EAGLE VISION HOME INSPECTION, LLC

## PROPERTY INSPECTION

2205 Ocoee St  
Chattanooga, TN 37406

09/24/2025

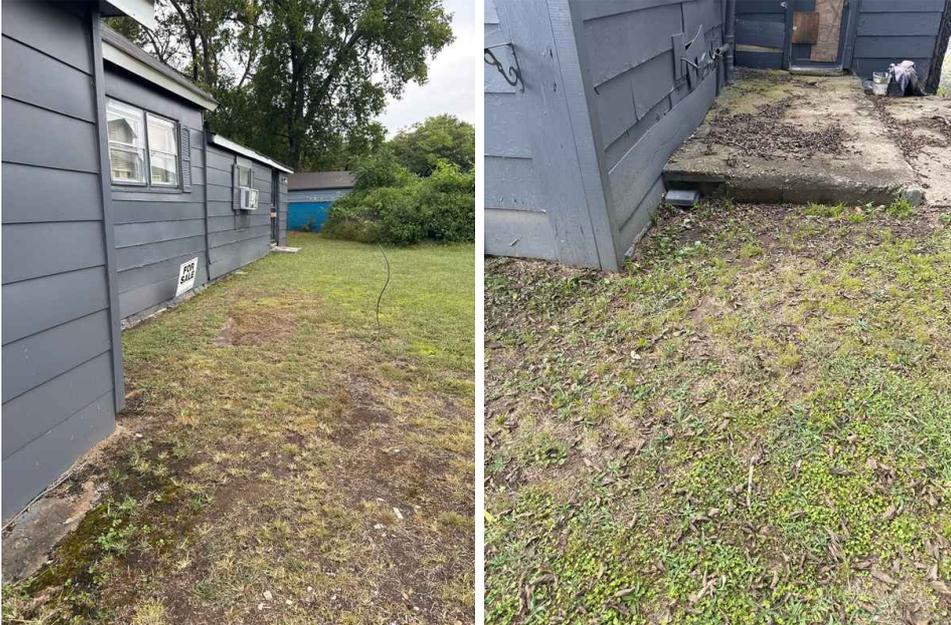
## 3.3.2 Grading/Lot Drainage

## Recommendation

Contact a qualified grading contractor.

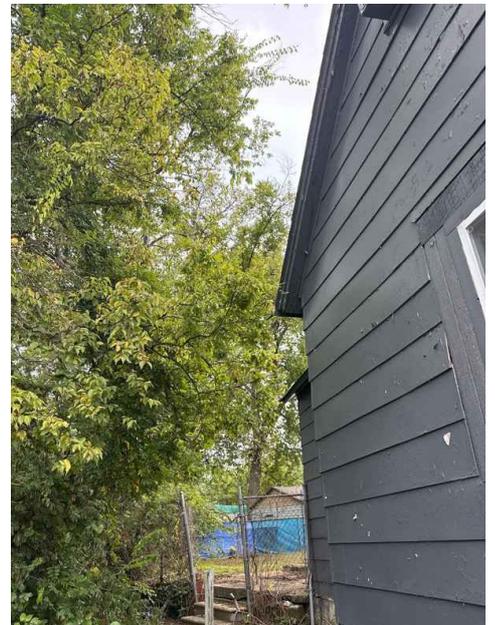
## 3.4.1 Vegetation Observations

## Recommendation

Contact a qualified tree service company.

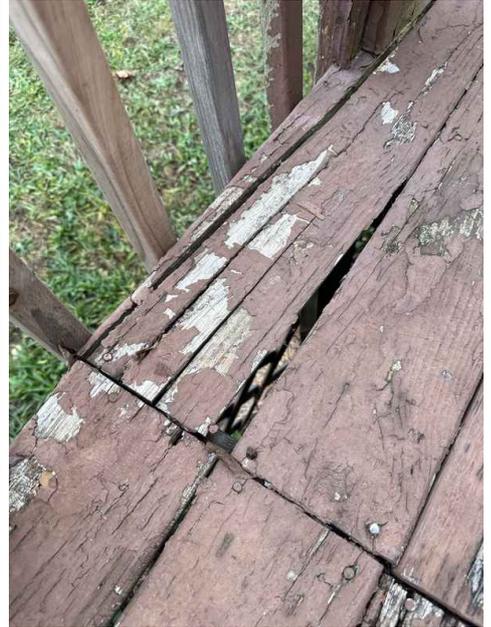
3.5.2 Porch(es)

Recommendation

Contact a qualified professional.

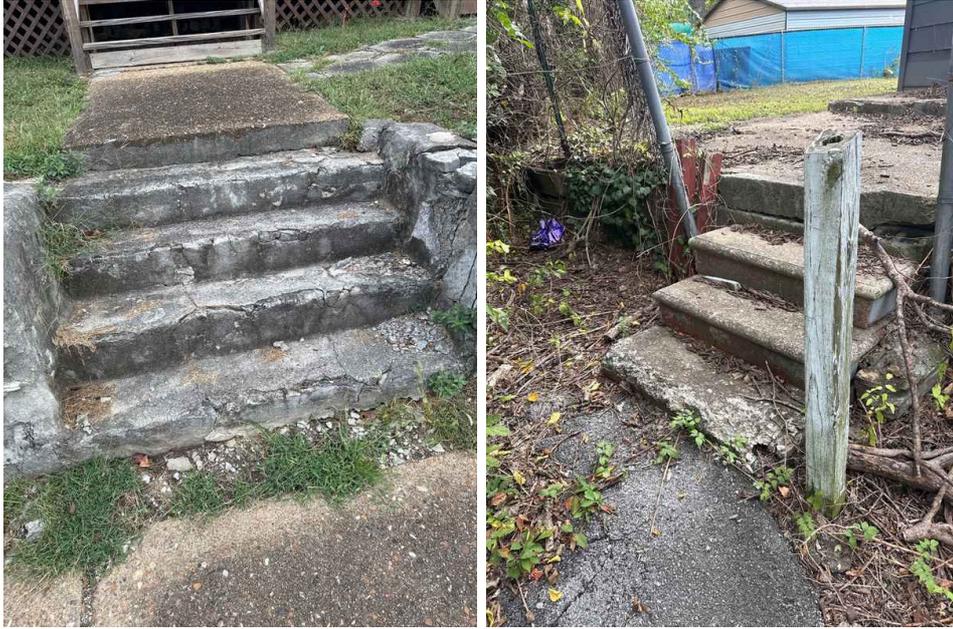
## 3.6.4 Stairs / Steps / Ramps

## Recommendation

Contact a qualified masonry professional.

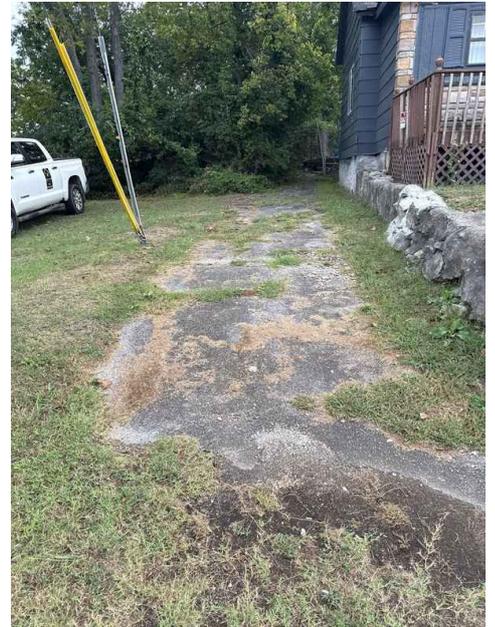
## 17.2.2 Exterior Hardscapes &amp; Flatwork - CSM

**ASPHALT - CRACKING**

## Recommendation

Contact a qualified driveway contractor.

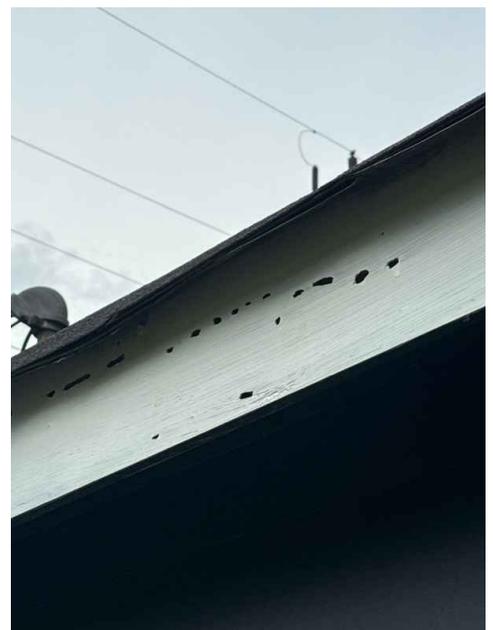
18.6.2 Pest / Insect / Wildlife Concerns

Recommendation

Contact a qualified pest control specialist.
