EAGLE VISION HOME INSPECTION, LLC

## PROPERTY INSPECTION

2205 Ocoee St  
Chattanooga, TN 37406

09/24/2025

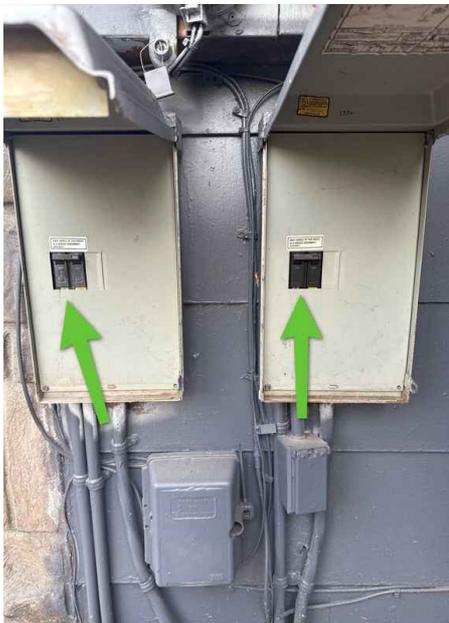
### Electrical Service Disconnect Information

The pictured electrical service disconnect will shut off all power to the home in the case of an emergency, or for servicing.

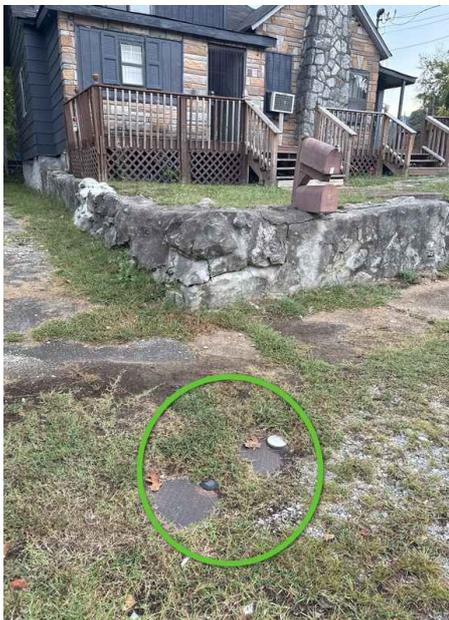
### Water: Water Shutoff Valve Location Information

The pictured water shutoff valve location will shut off the water supply in the home in the case of an emergency, or for servicing.

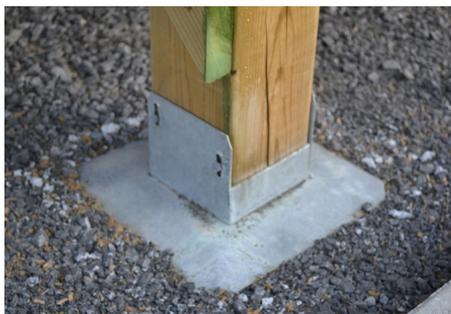
### Stairs / Steps / Ramps: Wood - Soil Contact Present

**FYI** - Wood to soil contact was present. Though this is a common practice, this can encourage decay of the support and framing members and be susceptible to wood destroying insect activity. Modifications to remove soil to provide for adequate clearance is recommended to be performed by a qualified person.

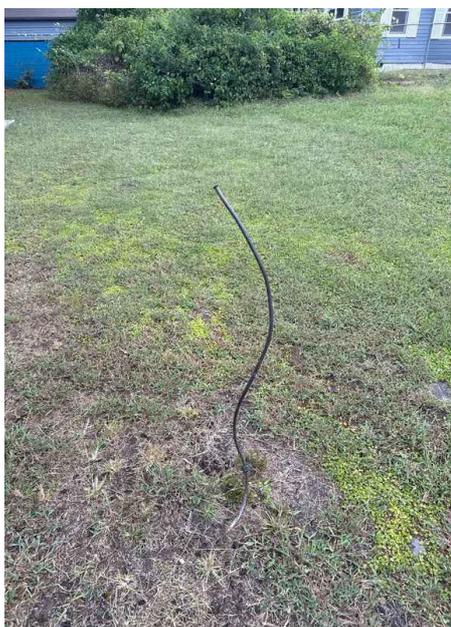
### Gas Meter/LP Tank Information: LP Tank - Removed

An LP tank was previously present at the home, but has been removed. Gas lines were still present on the exterior of the home.

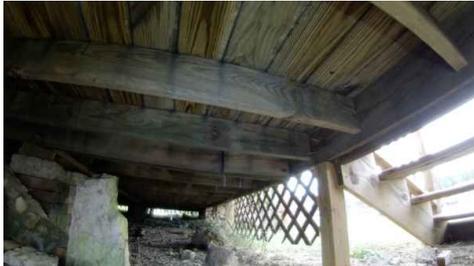
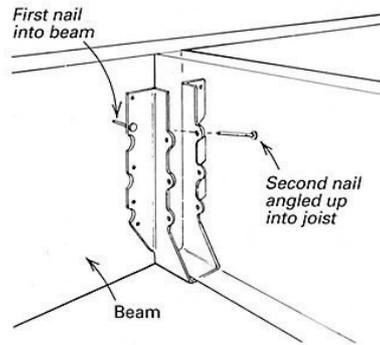
3.5.3 Porch(es)

- ⊖ 3.3.2 Grounds - Grading/Lot Drainage: Negative Grade Present
- ⊖ 3.4.1 Grounds - Vegetation Observations: Tree(s) - Limbs Within 10 Feet of Roof
- ⊖ 3.5.1 Grounds - Porch(es): Hardscape - Sloped Towards Home

Contact a qualified deck contractor.

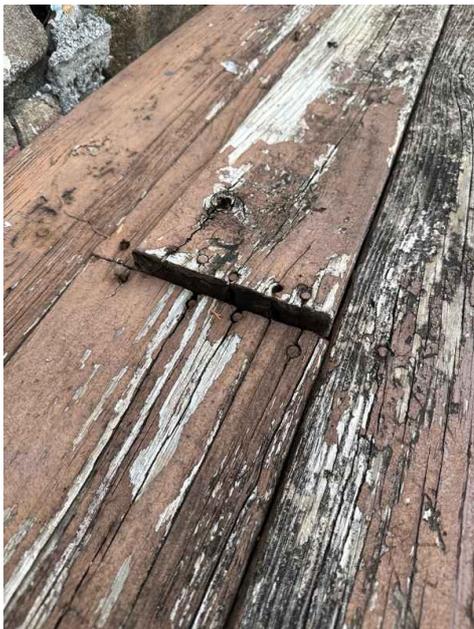
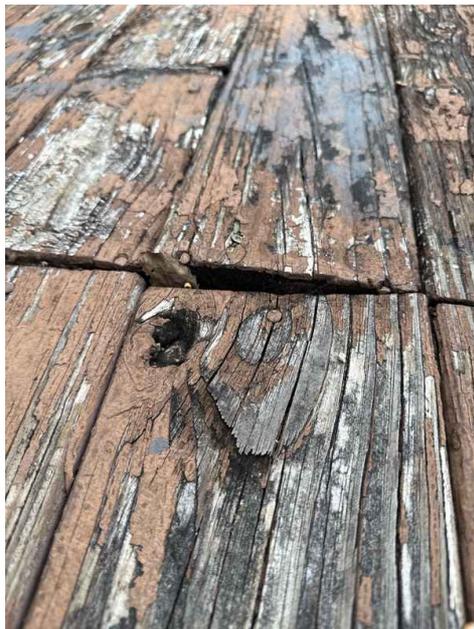
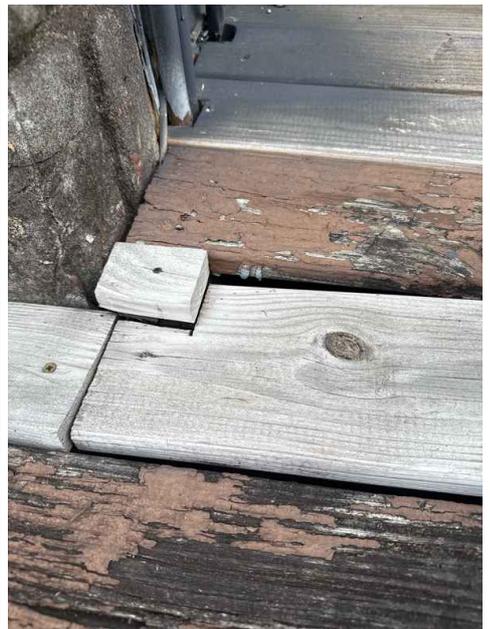
3.5.4 Porch(es)

- ⊖ 3.5.2 Grounds - Porch(es): Wooden Porch - Water Damage
- ⊖ 3.5.3 Grounds - Porch(es): Joist Hangers - Missing
- ⊖ 3.5.4 Grounds - Porch(es): Possible Trip Hazard(s) Present

Contact a qualified professional.

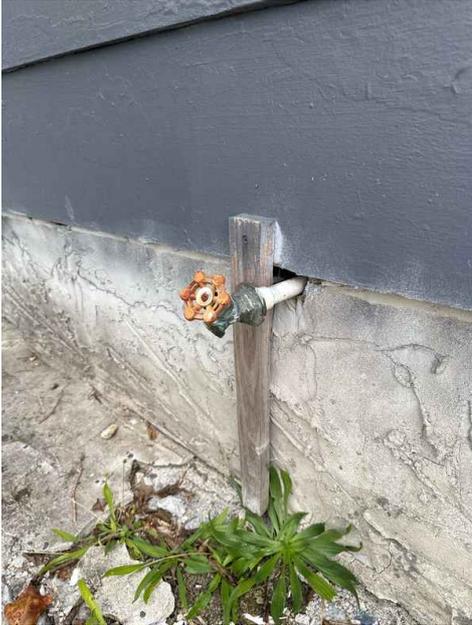
Left Side

- ⊖ 3.7.6 Grounds - Guardrails, Stair Rails, & Handrails: Wood - Weathered
- ⊖ 3.10.1 Grounds - Exterior Spigots: Spigot(s) - Not Secured / Loose at Wall

Contact a qualified professional.

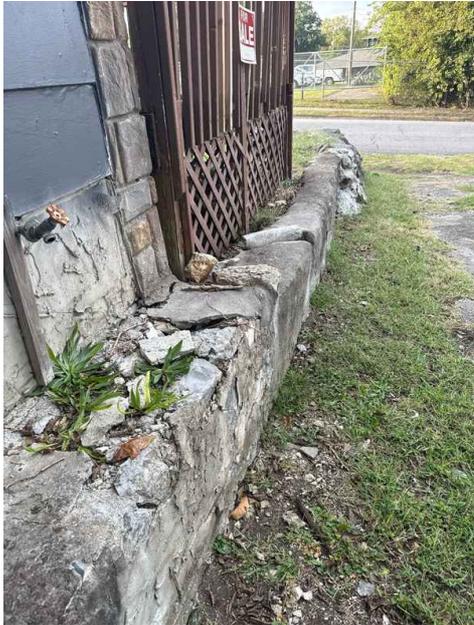
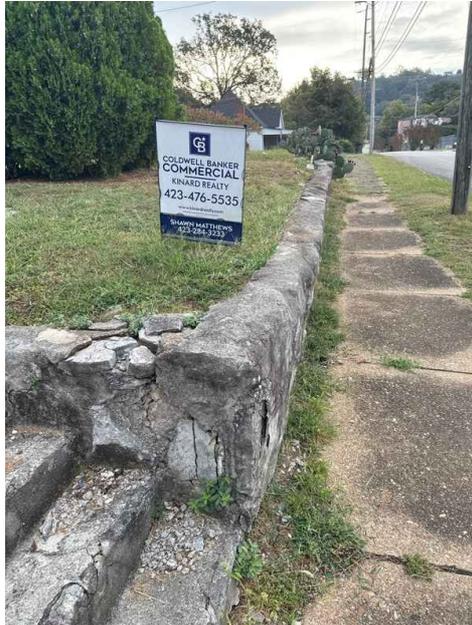
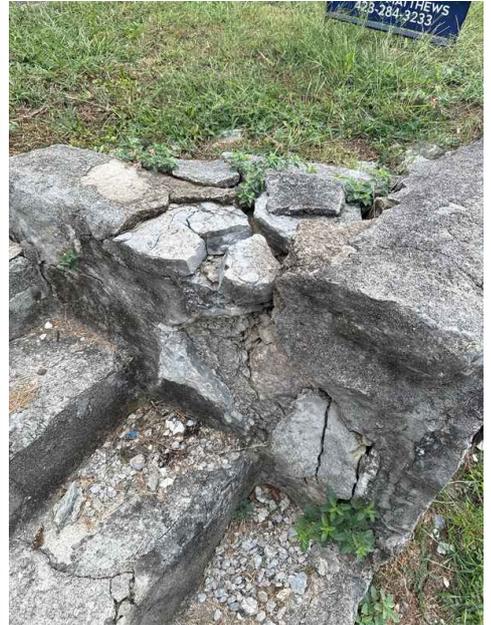
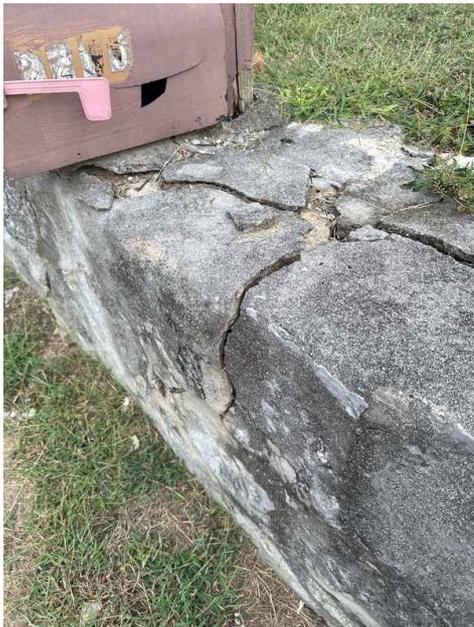
3.12.1 Retaining Wall

- ⊖ 3.12.1 Grounds - Retaining Wall: Retaining Wall - Cracking / Movement
- ⚠ 4.4.1 Roof - Shingles: Damage - Missing and/or Damaged Shingles
- ⊖ 4.4.2 Roof - Shingles: Repairs - Sealing of Shingles

Contact a qualified masonry professional.

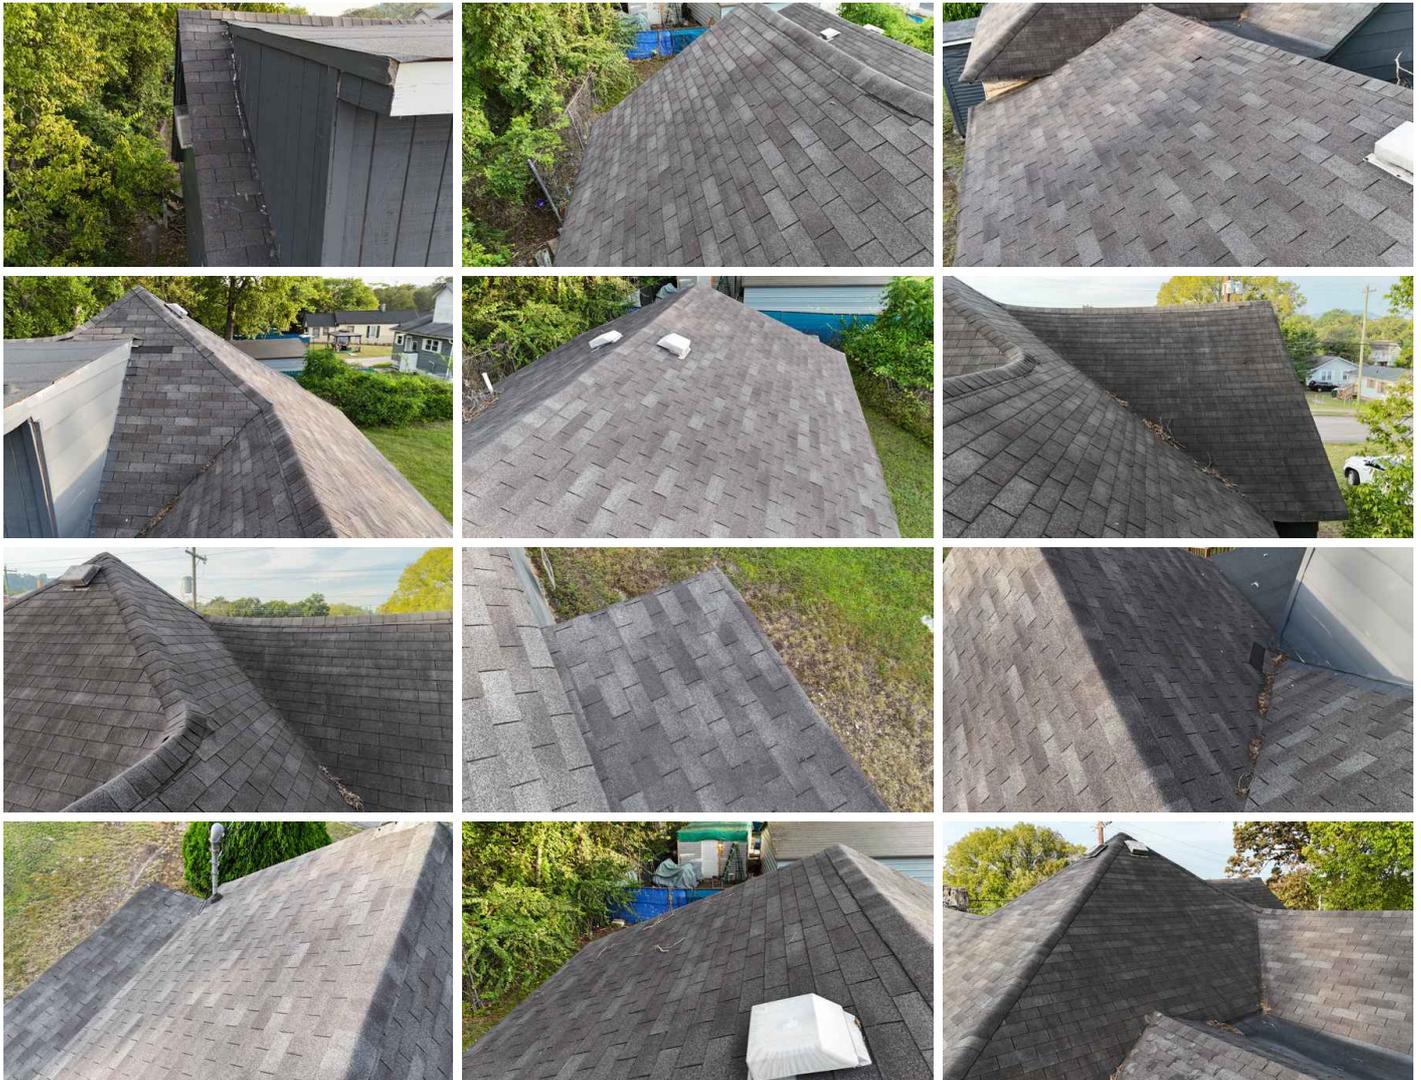
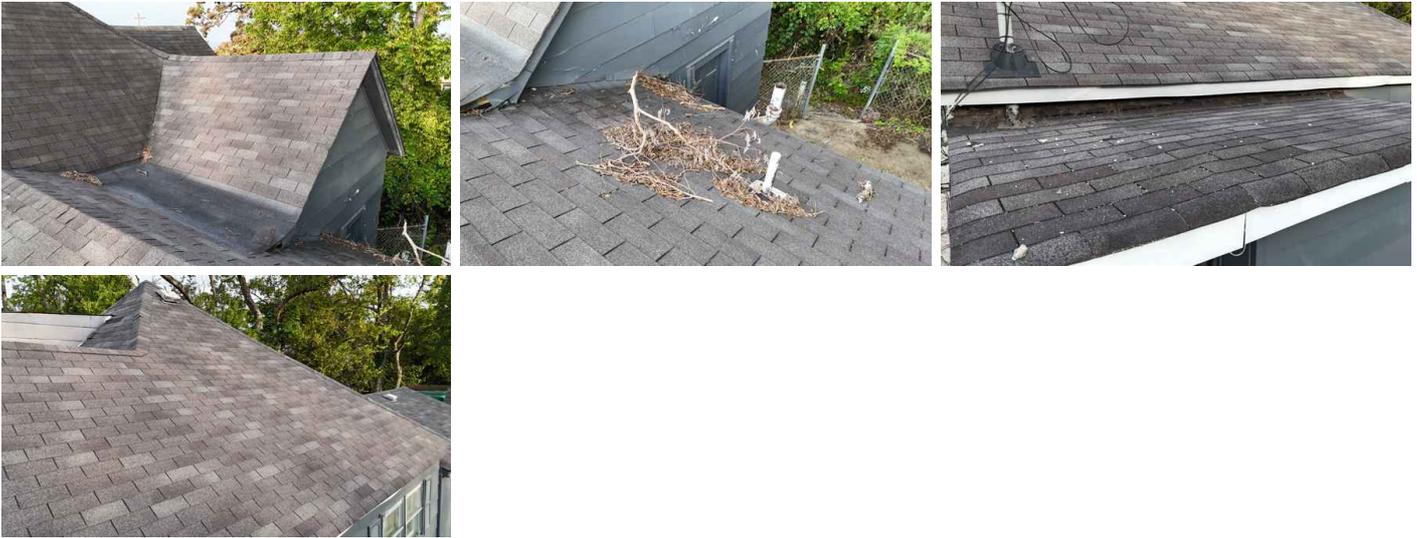
**General Info: Roof Views**

As routine maintenance, any nail/screw heads and seams should be sealed and checked annually. Apply, maintain, and replace sealant as necessary.

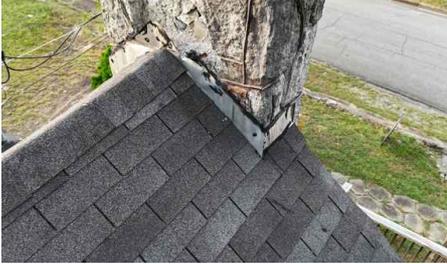
### Chimney: Chimney Flashing Sealed - Reglet Flashing Not Visible

The chimney step flashing is covered and therefore not visible for inspection. The area will be examined from the attic (if accessible/visible) looking for any indications of water/moisture infiltration. I recommend maintaining the sealant .

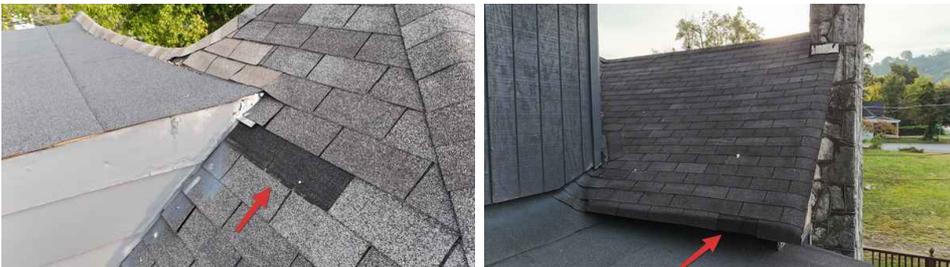
### 4.4.1 Shingles

#### **DAMAGE - MISSING AND/OR DAMAGED SHINGLES**

There were missing and/or damaged shingle(s) present on the roof surface. Repairs are recommended to be conducted as needed by a roofing contractor or other qualified person.

Contact a qualified roofing professional.

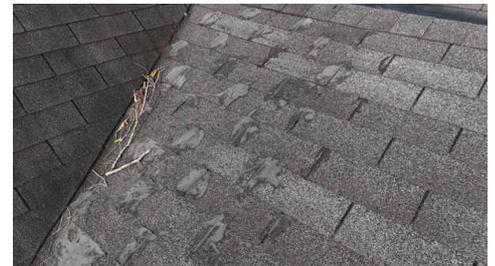
### 4.4.2 Shingles

#### **REPAIRS - SEALING OF SHINGLES**

Previous repairs (sealing of shingles) have been conducted to areas of the roof surface. Shingles should prevent leaks without the use of sealant. An evaluation of these area(s) with repairs or replacement of the affected shingles as needed is recommended to be conducted by a licensed roofing contractor.

Contact a qualified roofing professional.

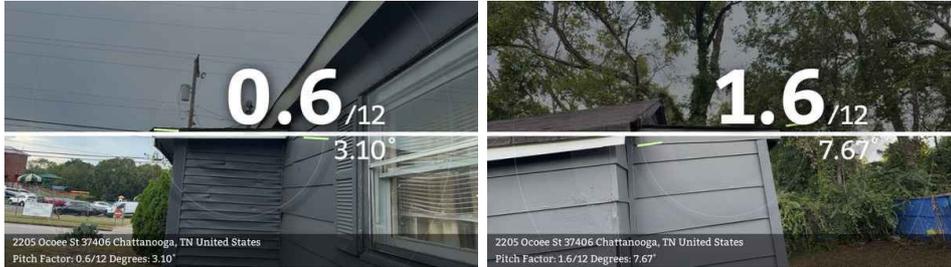
## 4.4.3 Shingles

Marginal Defect
**PITCH - SHINGLES INSTALLED ON LESS THAN 2/12**

There were shingles installed on less than a 2/12 pitch, which can possibly allow for water infiltration between the shingles. EPDM rubber roof membranes or another low pitch approved material is recommended in this application. Evaluation and replacement of the shingles with an appropriate covering is recommended to be conducted by a roofing contractor.

Contact a qualified roofing professional.

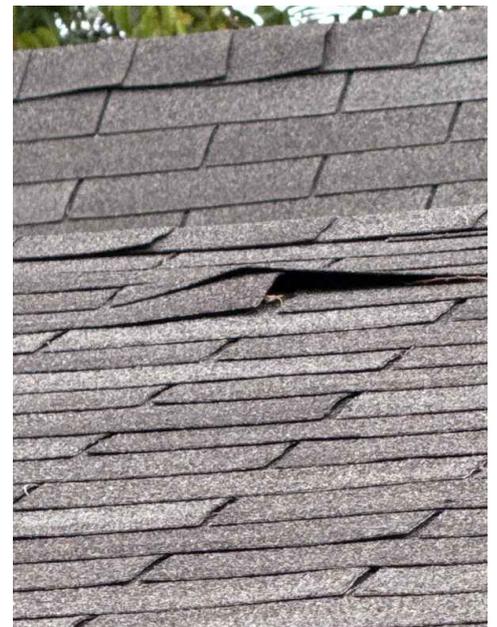
Marginal Defect
**SURFACE - LIFTED SHINGLES**

There were lifted shingles present on the roof surface. This allows the shingles to be susceptible to tear-off damage from the wind as well as possibly exposing underlying areas to rain, creating the possibility of leaks. Repairs to properly "adhere" or repair any lifted or damaged shingles is recommended to be conducted by a roofing contractor.

Contact a qualified roofing professional.

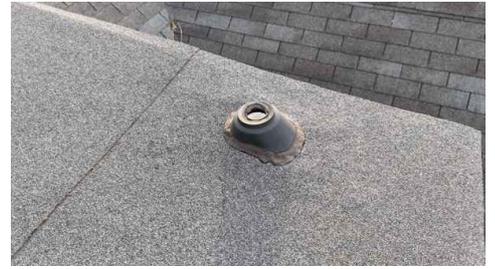
## 4.5.1 Vents/Roof Protrusions

Significant Defect
**BOOT(S) - PRESENT WITH NO PROTRUSION**

A rain boot was present without the vent protruding through it. This creates an opening into the attic where rain or wildlife can enter. Repairs are recommended to be performed here as needed by a roofing contractor and/or plumbing contractor.

Contact a qualified roofing professional.

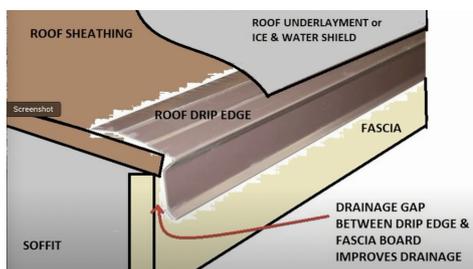
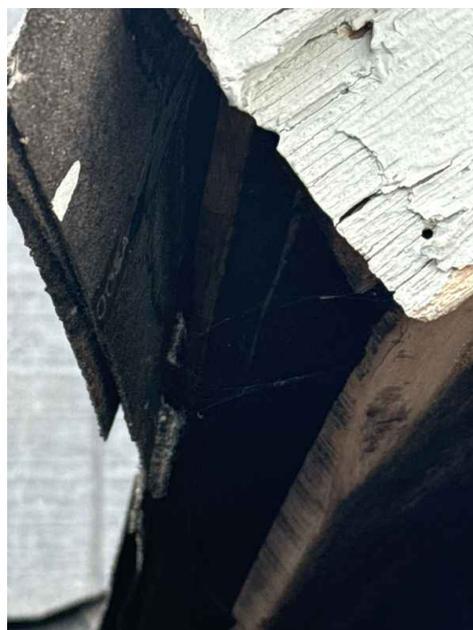
## 4.6.1 Roof Flashings

Marginal Defect
**DRIP EDGE FLASHING - MISSING**

Drip edge flashing was not present in areas that were checked. Before 2012, roofers extended roofing material a little further to help prevent moisture from reaching the sheathing. Today, drip edge flashing is recommended to be installed at the eaves and rakes of the roof (called rake edge at the gables), to protect the edges of the sheathing from sustaining water damage. The installation of proper drip edge flashing is recommended to be conducted by a roofing contractor.

Contact a qualified roofing professional.

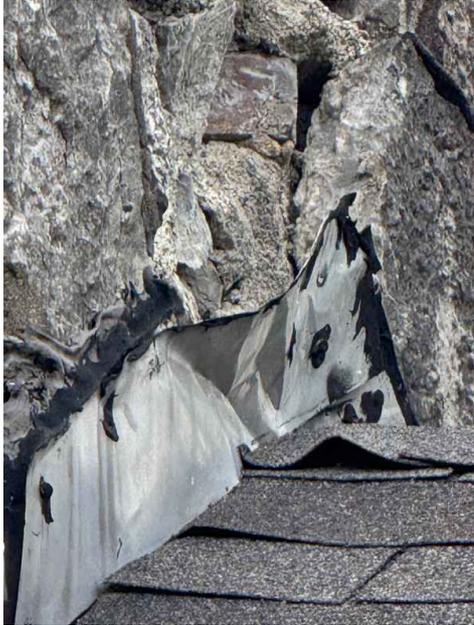
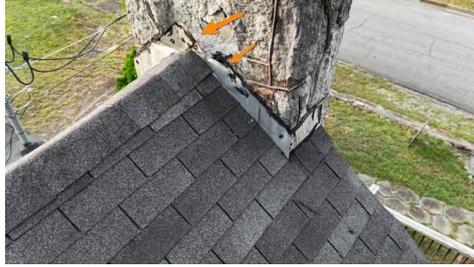
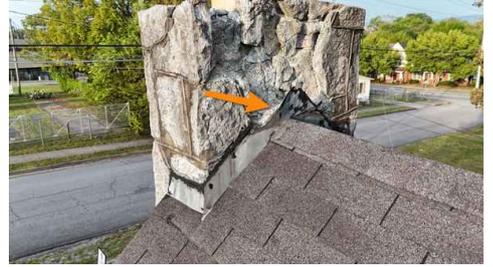
## 4.7.1 Chimney

Marginal Defect**FLASHING - DISPLACED**

There were areas of displaced flashing present. This can allow for roof leaks at the chimney area. Repairs to the flashing as needed to prevent leaking is recommended to be performed by a qualified contractor.

Contact a qualified professional.

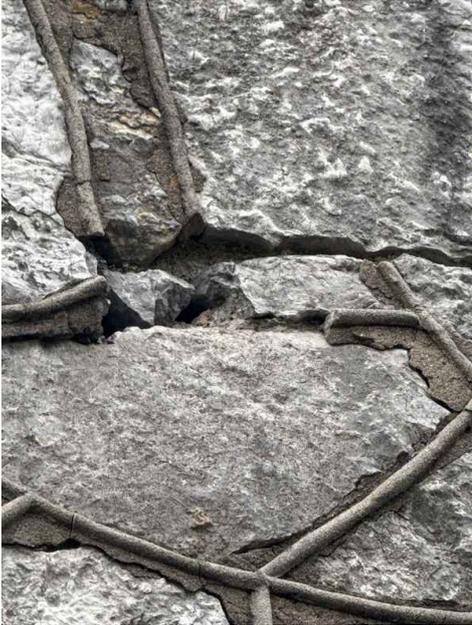
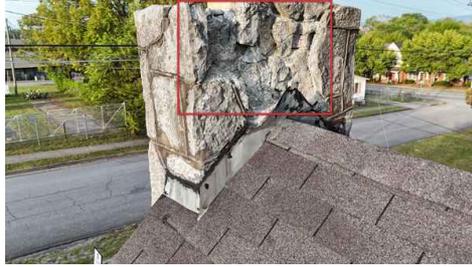
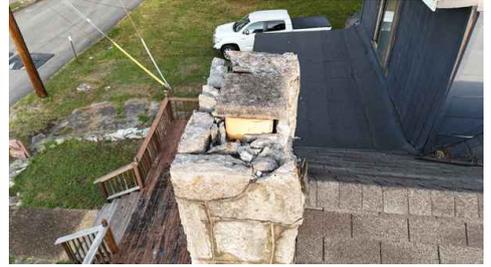
## 4.7.2 Chimney

**MASONRY - CRACKING / FAILING**

There was cracking present on areas of the masonry. An evaluation of the masonry with repairs made as needed is recommended to be performed by a qualified mason.

Contact a qualified masonry professional.

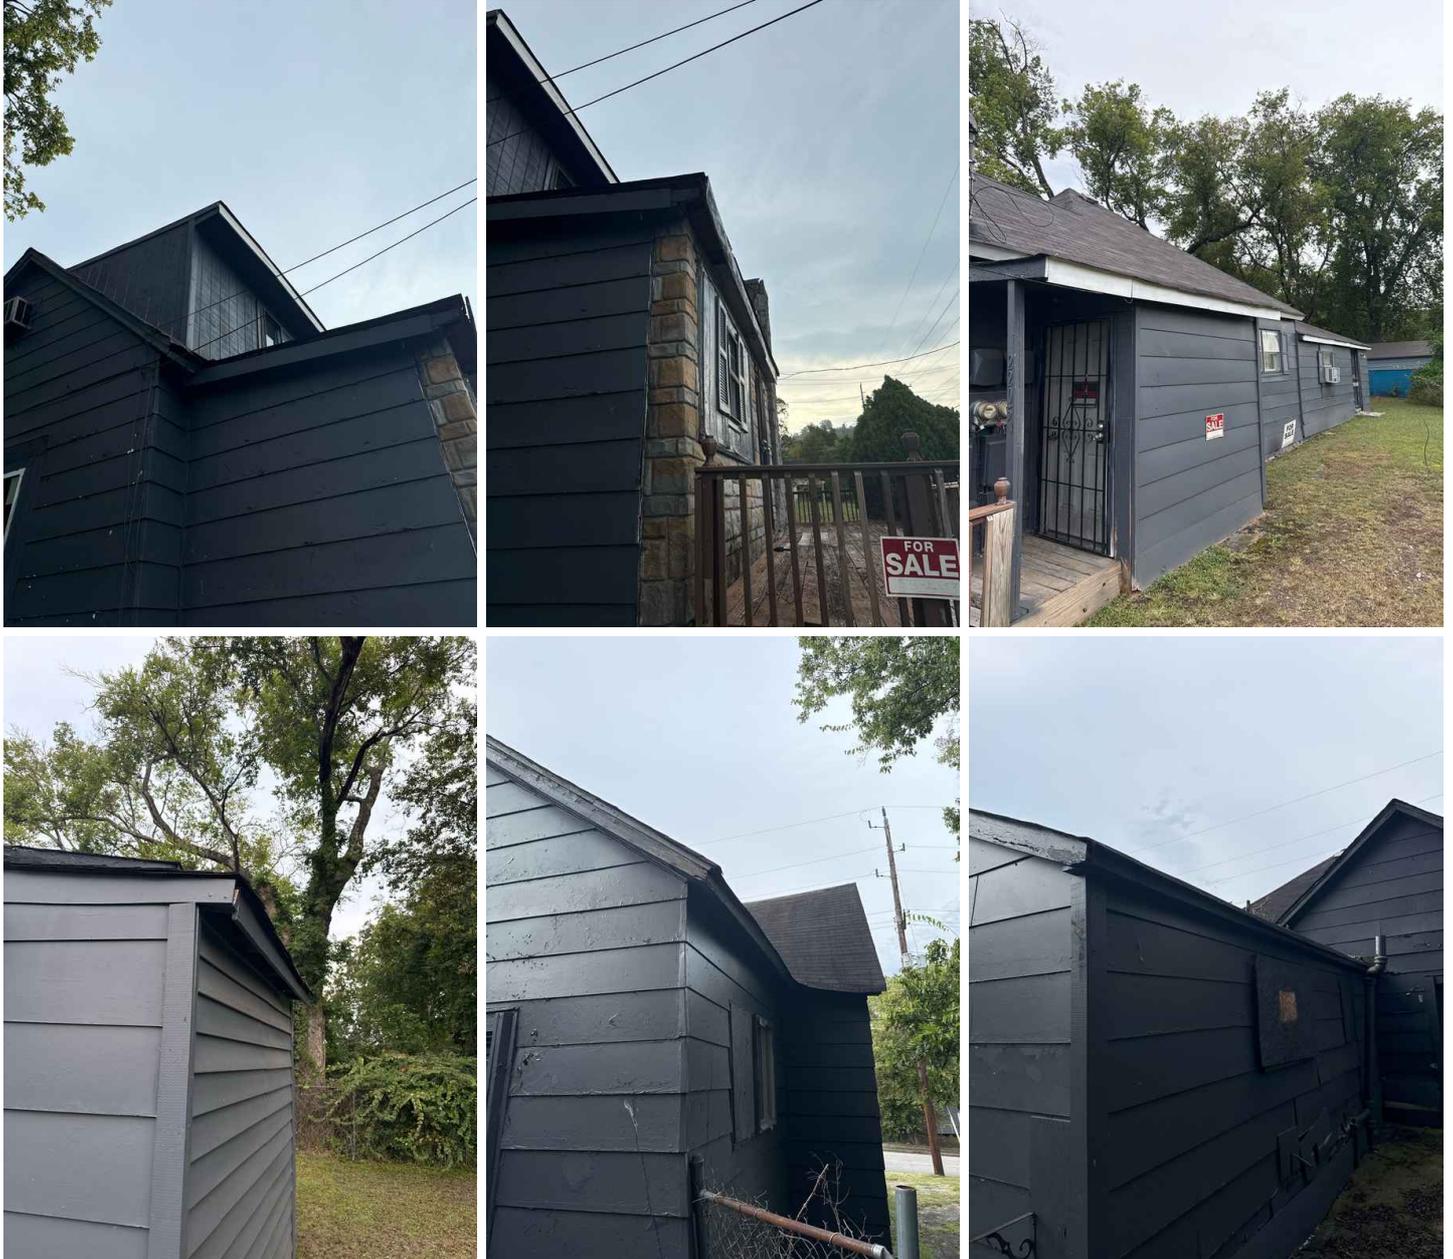
4.8.1 Gutters / Downspouts

Marginal Defect

There were no gutters present. The installation of gutters by a qualified contractor is recommended to manage rainwater. Without guttering present the grounds surrounding the foundation will become saturated, potentially allowing for settlement and moisture intrusion.

Contact a qualified gutter contractor

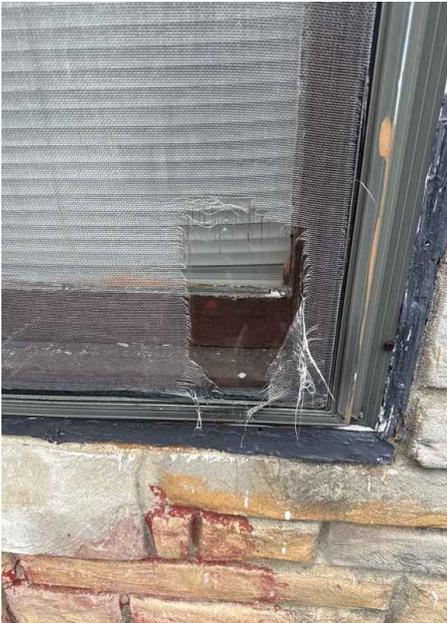
\*NOTE: there are some windows missing screens

FYI-some screen damage

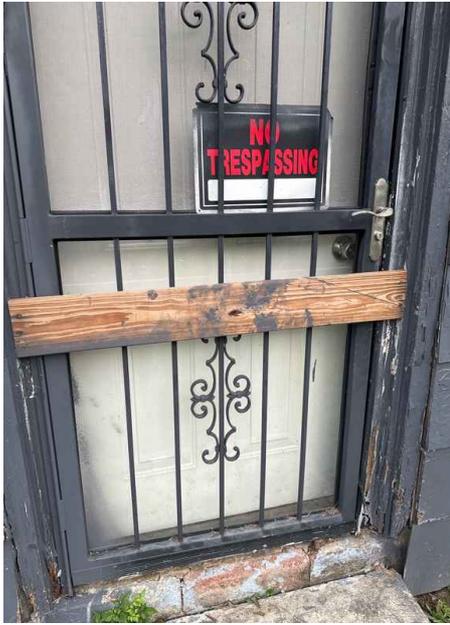
Right Side

### Exterior Doors: Door Blocked

**LMT** - I was unable to operate the referenced door(s), due to being blocked at the time of inspection. I recommend confirming proper operation prior to close.

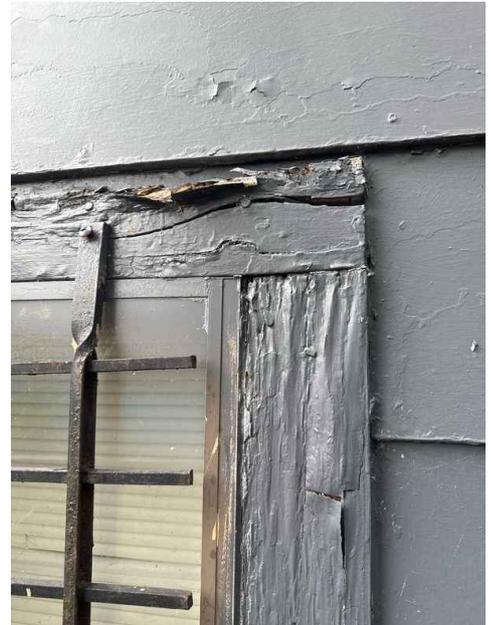
5.6.2 Window Exteriors

➔ Marginal Defect

**SEALANT - DETERIORATED/CRACKED**

There were areas of sealant around the windows that were deteriorated and/or cracked. This can potentially allow for moisture or insect infiltration. An evaluation of all windows and re-application of sealant is recommended as needed at any areas with damaged, deteriorating, or missing sealant by a qualified person.

Contact a qualified professional.

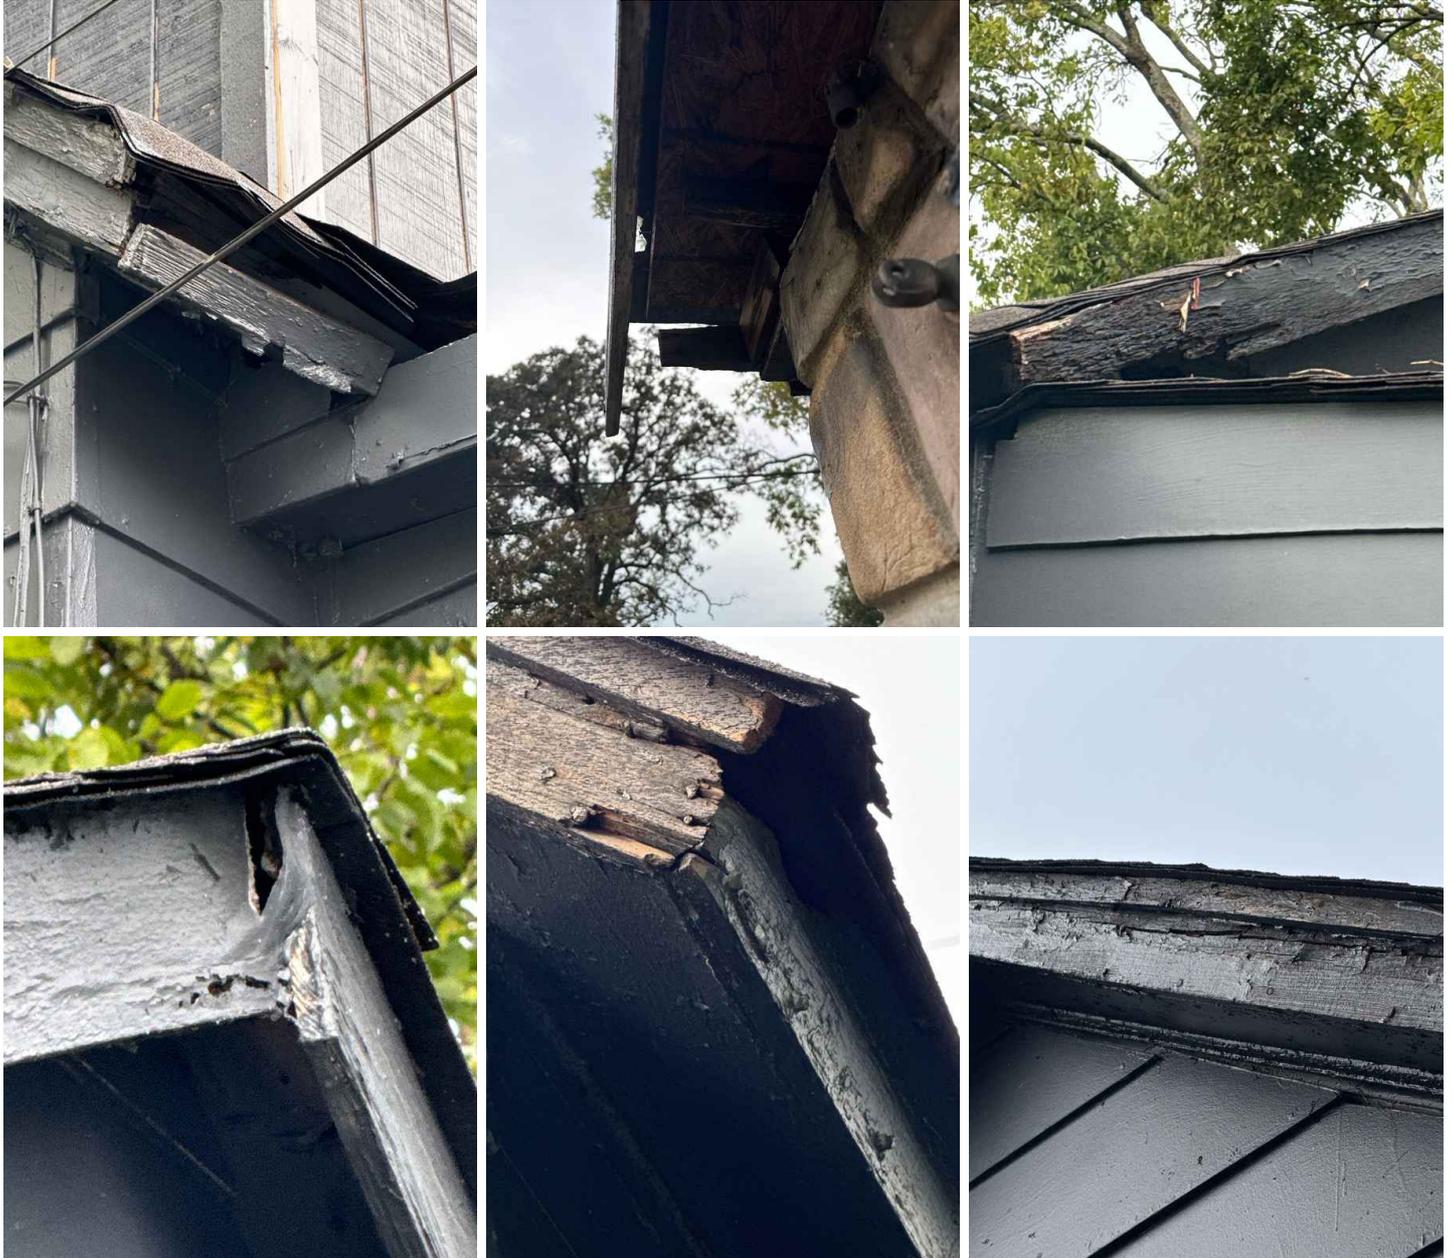
5.9.1 Sealant/Paint Overall

Marginal Defect

**GENERAL - PAINT/SEALANT RECOMMENDED AT AREA(S)**

The referenced area(s) were in need of paint/sealant application. A low modulus paint/sealant is recommended for sealing areas consisting of different building materials. The application of paint/sealant at any areas in need is recommended to be conducted by a qualified contractor.

Contact a qualified professional.

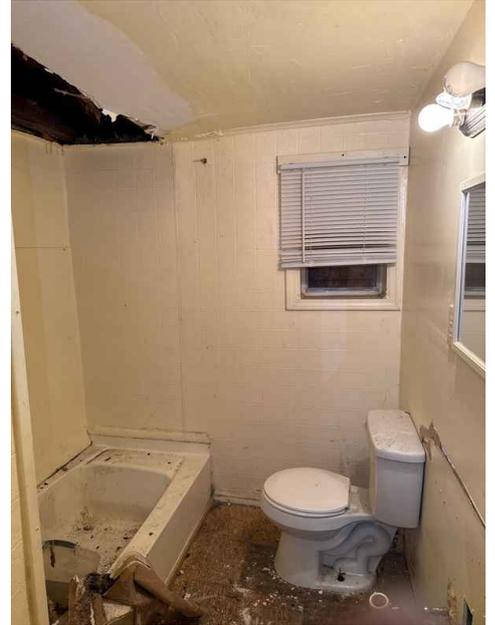
Unit 2

Marginal Defect**VENTILATION FAN OR WINDOW - NOT PRESENT**

No exhaust fan or window was present in the referenced bathroom(s). Current standards state that an exhaust fan should be present in bathrooms to ensure proper ventilation of moisture. Ventilation in 1/2 baths are also recommended. The installation of an exhaust fan is recommended to be performed by a licensed electrician.

Contact a qualified electrical contractor.

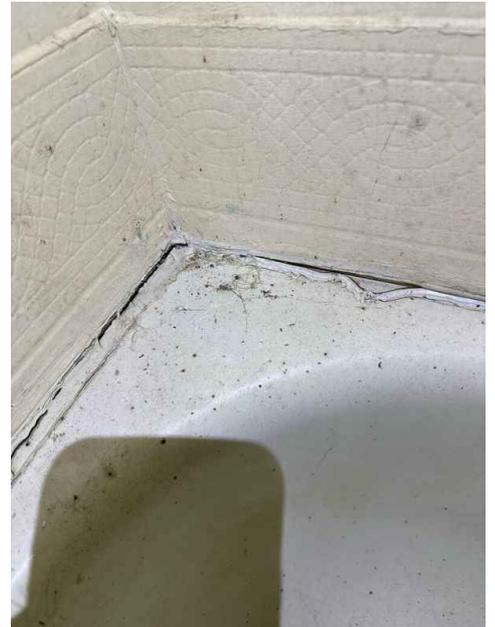
Unit 1

## 7.3.1 Bathtub(s)

Marginal Defect**GENERAL - SEALANT GAPS/MISSING**

Contact a qualified handyman.

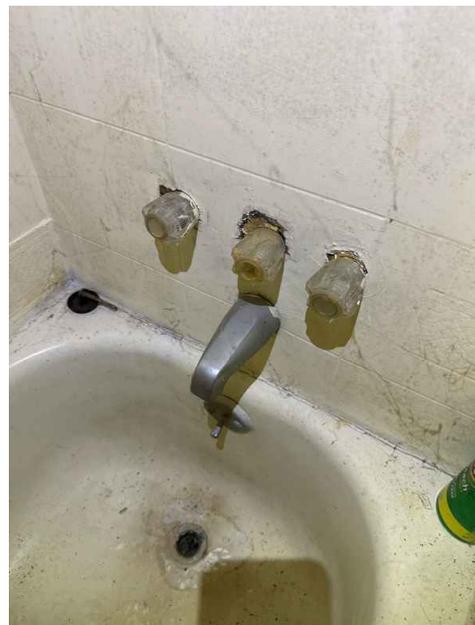
Unit 1

## 7.3.2 Bathtub(s)

**FAUCET/VALVES - LOOSE**

Marginal Defect

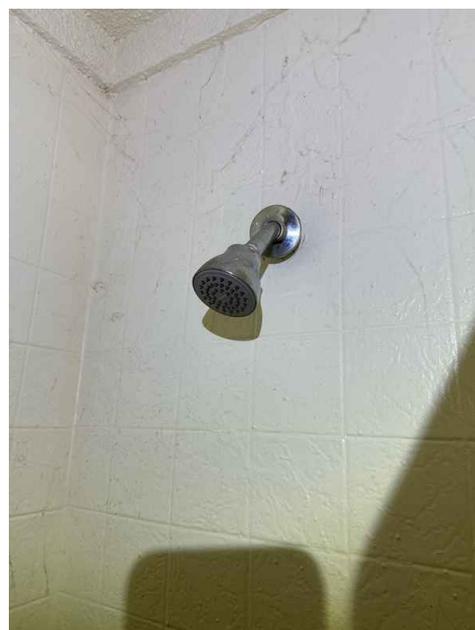
Unit 1

## 7.4.1 Shower(s)

Marginal Defect

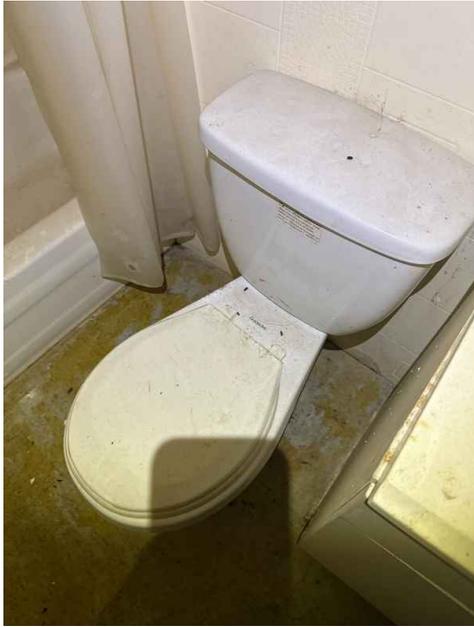
Unit 1

## 7.6.1 Toilet(s)

Contact a qualified plumbing contractor.

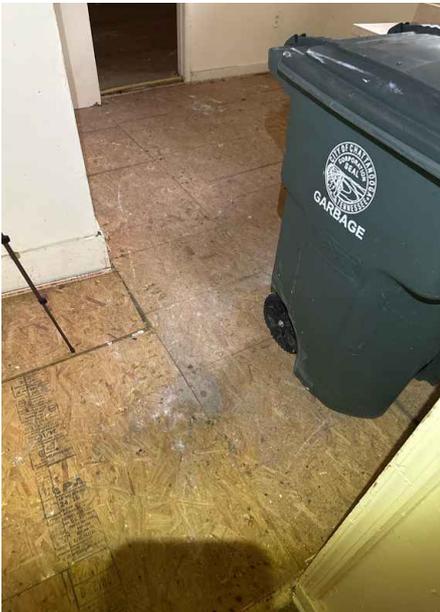
Applies to areas of both units

**Floor Condition: Floor Coverings - Missing/Incomplete**

**FYI** - The floor coverings in area(s) were incomplete. Finish as desired.

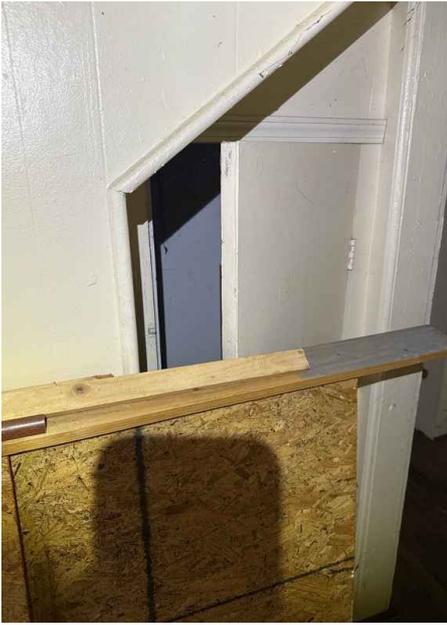
Unit 1

**General Info: Area blocked - Not Inspected**

**LMT** - A area was blocked at the time of inspection. This room and its items and components are excluded from this inspection.

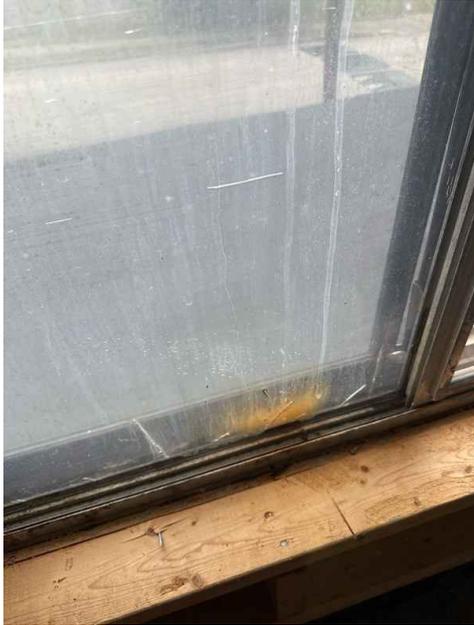
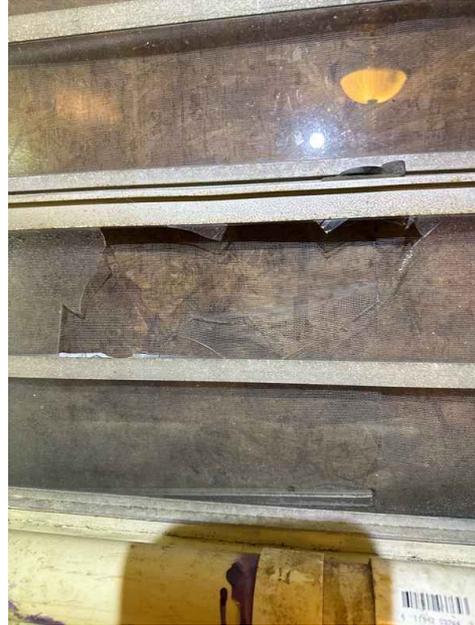
**GLASS - BROKEN PANE PRESENT**

Broken glass was present on the referenced window(s). Replacement of the glass or window as needed is recommended to be performed by a window company or glazing contractor.

Contact a qualified window repair/installation contractor.

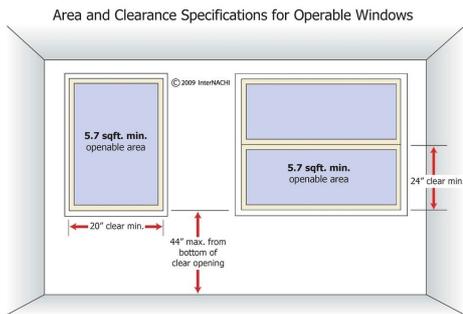
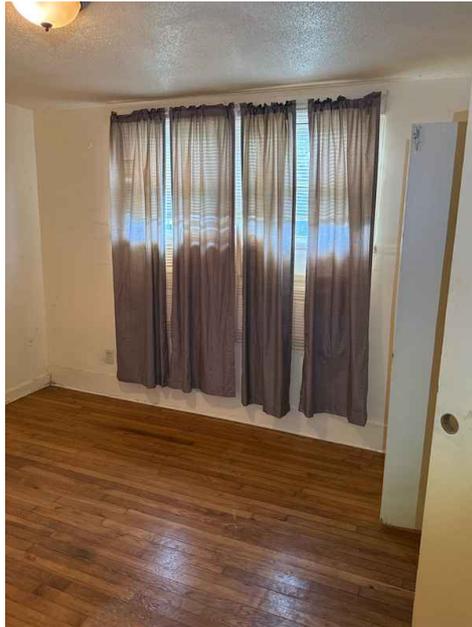
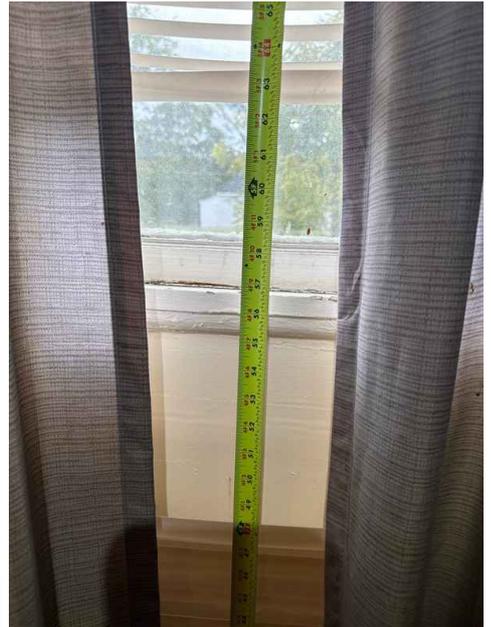
**SAFETY - EERO DEFICIENCIES (SLEEPING AREAS)**

**SFTY** - There were window(s) present in sleeping room(s) that would not meet today's escape and rescue opening requirements. Current fire safety standards require if a window is used as the escape and rescue opening, it must be within 44 inches of the floor, as well as meeting sizing requirements of 24" high and 20" wide. I recommend consulting with a qualified contractor or window installation contractor to discuss possible upgrades to meet current fire safety requirements.

\*This is typical of older homes. If you choose not to modify the windows, I recommend situating furniture to step up on for easy escape access.

Contact a qualified professional.

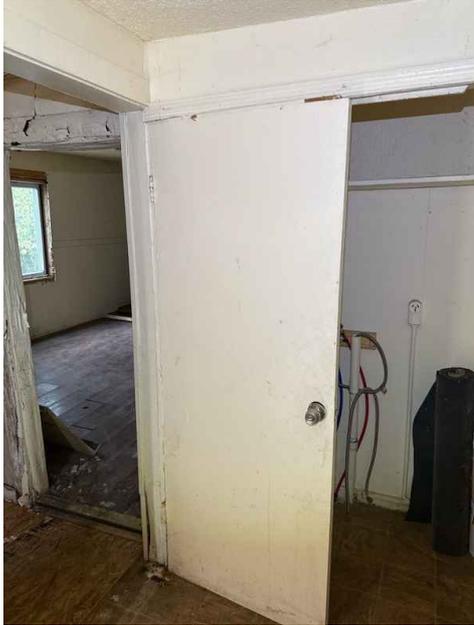
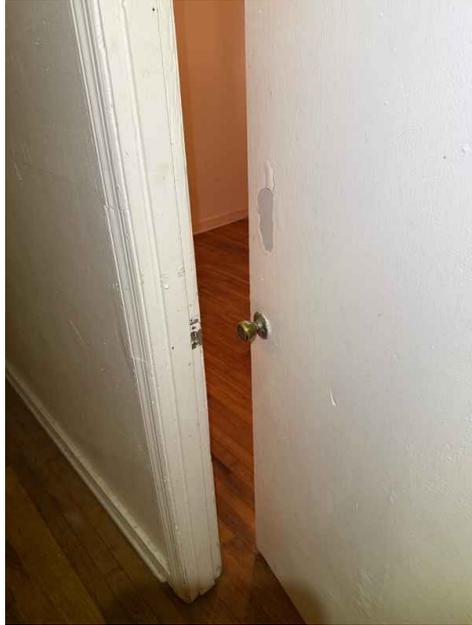
There were door(s) that were binding / rubbing on an adjacent surface. Adjustments or modifications are recommended to be conducted by a qualified person as needed for proper operation.

Contact a qualified handyman.

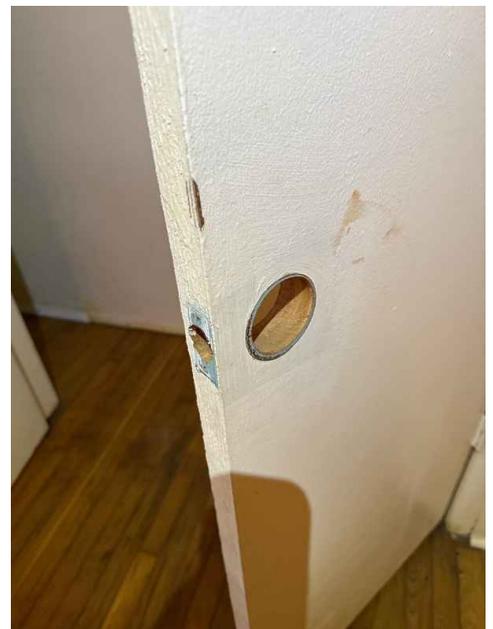
Unit 2 Bedroom Closet

**HARDWARE - MISSING**

The referenced door(s) were missing hardware; this can include: handle sets, striker plates, fasteners, hinges, etc. The installation of missing parts as needed to achieve proper operation is recommended to be conducted by a qualified person.

Contact a qualified professional.

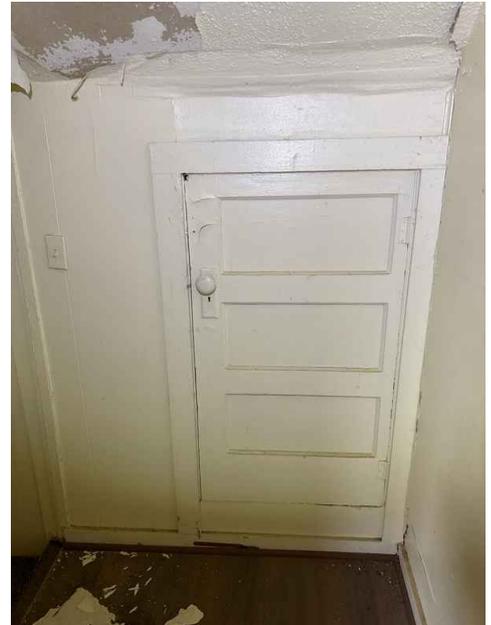
Unit 1

The referenced door(s) were "stuck" in the closed position at the time of inspection. Repairs to the door as needed for proper operation is recommended to be performed by a qualified professional.

Contact a qualified professional.

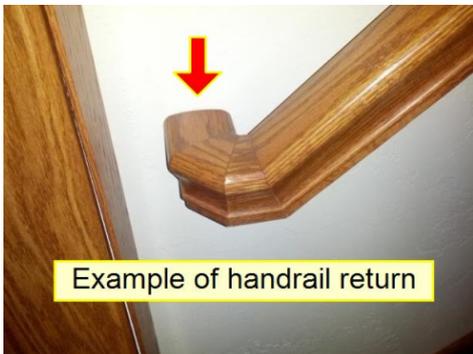
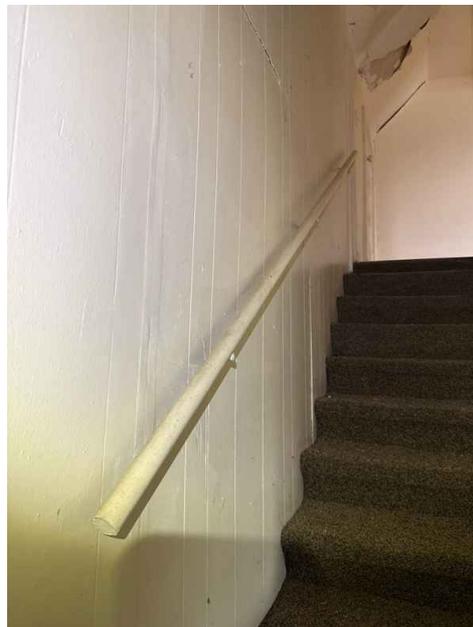
Unit 1

**HANDRAIL - RETURNS MISSING**

**SFTY** - Returns were not present on the handrail(s). Current safety standards recommend for the handrails to "return" to the wall, so that clothing, etc. won't be snagged by a handrails end. Safety upgrades to "return" the handrail to the wall is recommended to be conducted by a qualified person.

Contact a qualified professional.
