EAGLE VISION HOME INSPECTION, LLC

## PROPERTY INSPECTION

2205 Ocoee St  
Chattanooga, TN 37406

09/24/2025

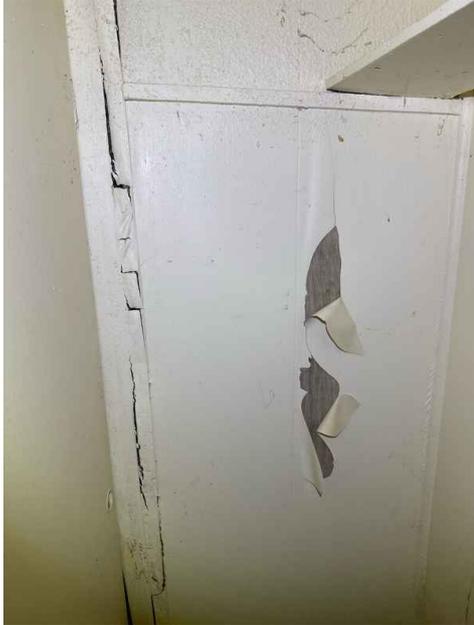
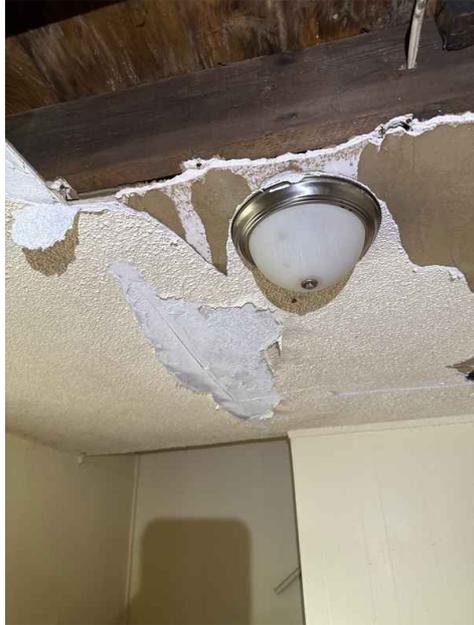
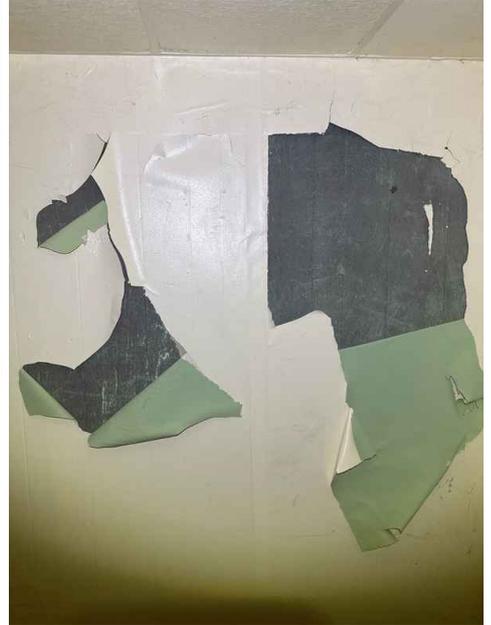
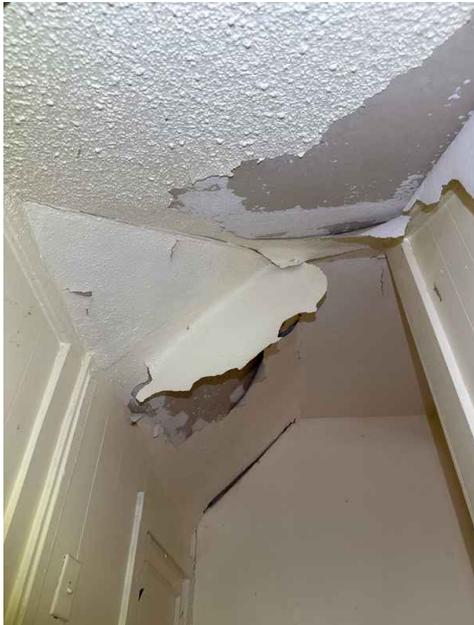
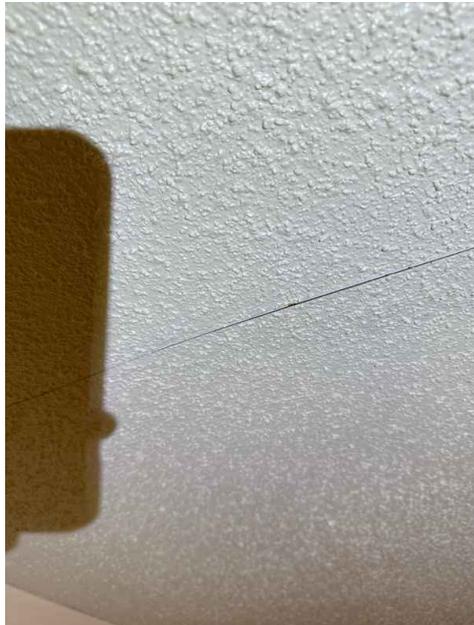
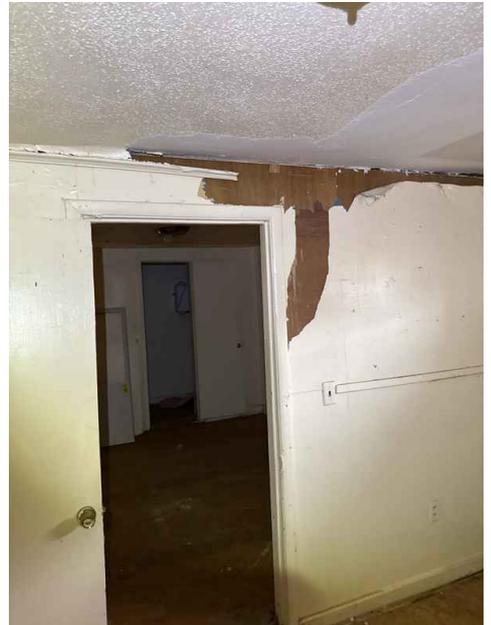
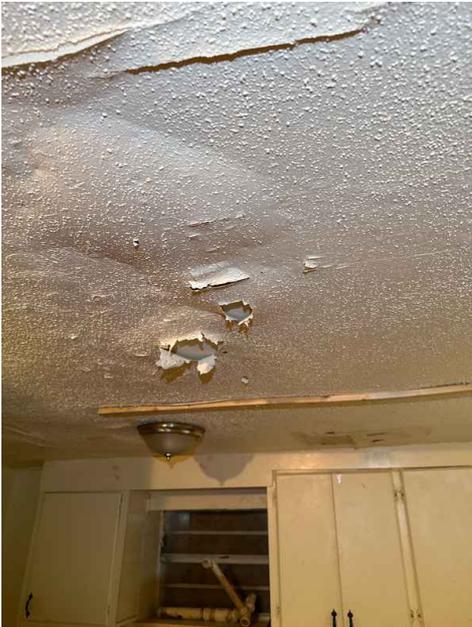
Flaking paint was present. A full evaluation is recommended by a qualified person with prep and painting to any affected area.

Contact a qualified professional.

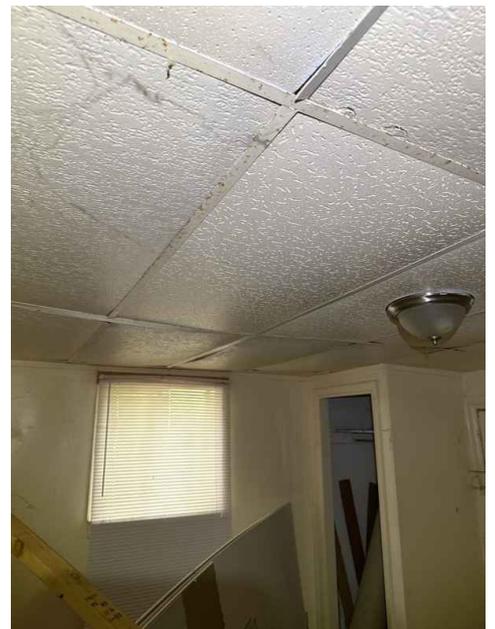
Unit 1

**CEILING TILES(S) - DEFICIENCIES**

There were ceiling tile(s) present with deficiencies. If concerned, repairs to the tiles are recommended as needed by a qualified person.

Contact a qualified professional.

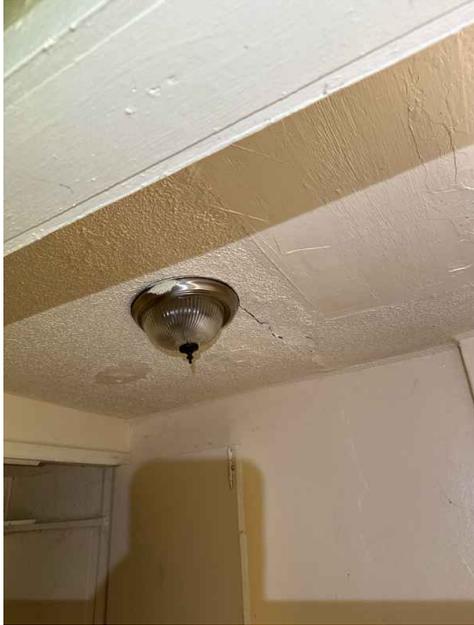
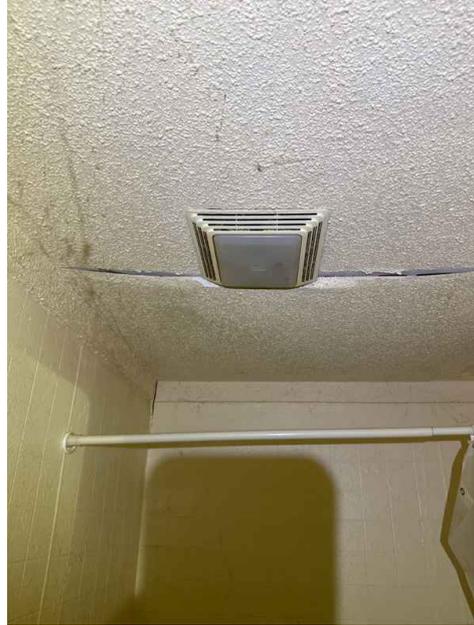
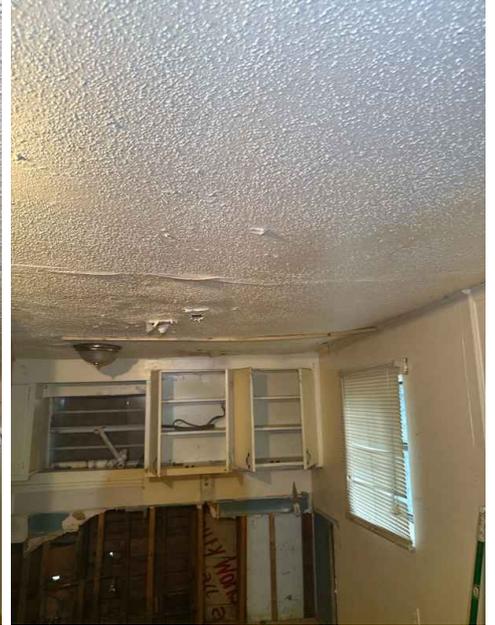
Marginal Defect
**CEILING(S) - SAGGING**

The ceiling was sloping or sagging in the referenced area. A full evaluation is recommended by a qualified person to determine the cause of any sagging area, with repairs made to correct it.

Contact a qualified professional.

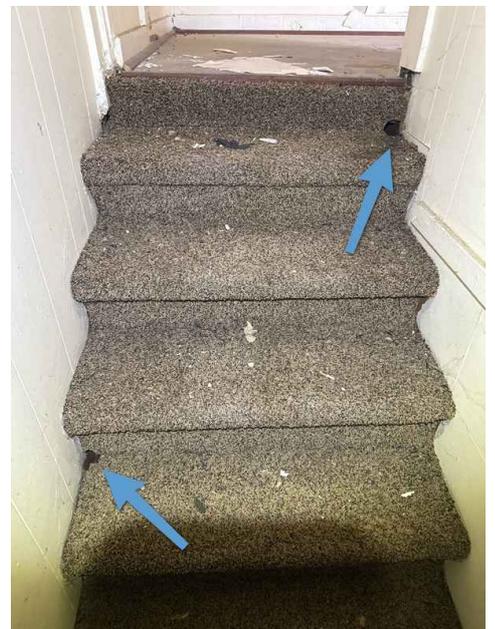
Unit 1

Minor Defect, Maintenance Item, or FYI Item
**GENERAL - HOLE(S) IN FLOORING AND/OR STAIRS**

There were hole(s) in the flooring and/or stairs at the referenced area(s). Repairs to these holes are recommended to be performed as needed by a qualified person.

Contact a qualified professional.

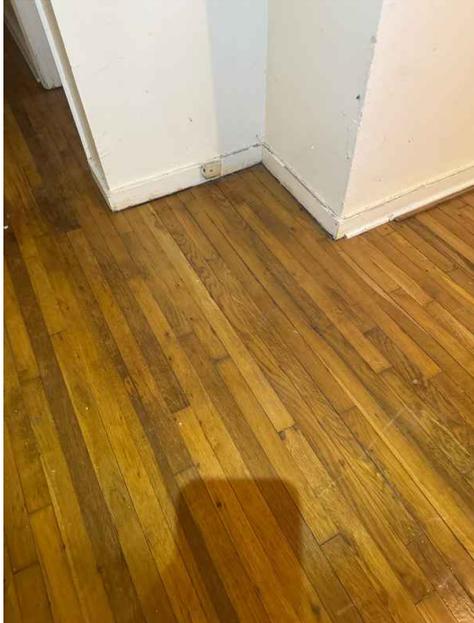
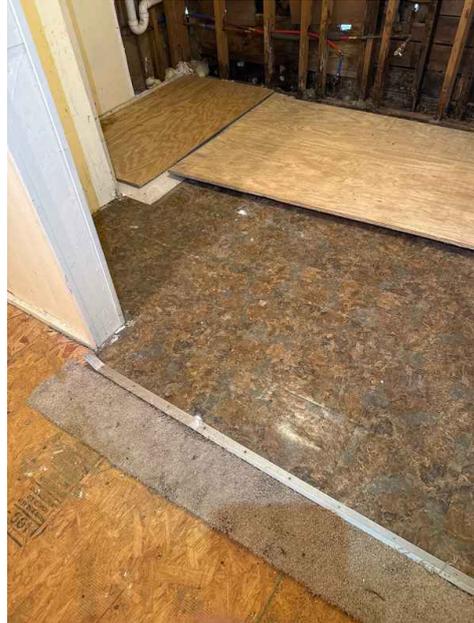
A "soft area" was present on the referenced area of the floor. An invasive evaluation of the area(s) and repairs made as needed is recommended to be performed by a qualified contractor.

Contact a qualified professional.

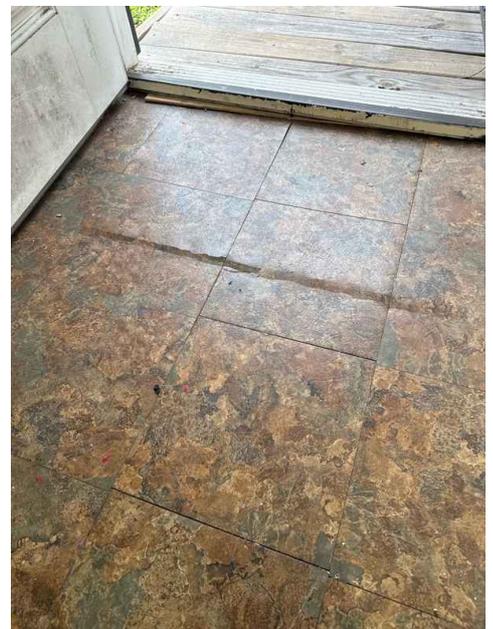
Unit 2

**LAMINATE FLOORING - DEFICIENCIES**

Cosmetic deficiencies were present on portions of the laminate flooring in a few area(s). If a concern for you, an evaluation of the flooring and repairs as needed is recommended to be performed by a flooring contractor.

NOTE: I didn't photograph every deficient area

Contact a qualified flooring contractor

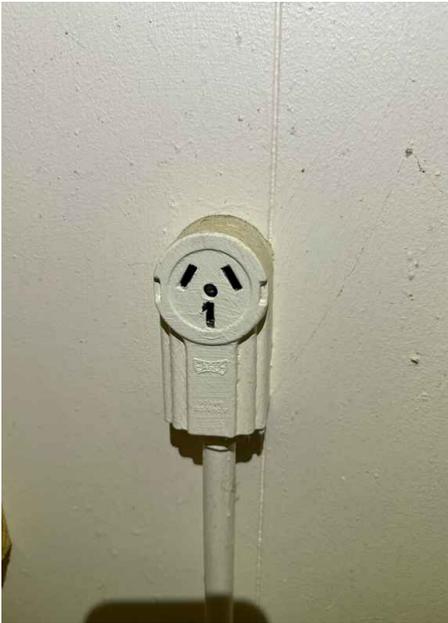
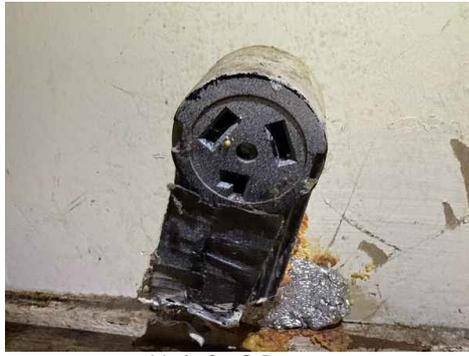
Existing homes may still use 3-prong outlets, as the NEC changes are limited strictly to new homes. Although the old 3-prong outlets were effective at providing power to dryers, the ground and neutral wires were grouped together, creating the potential for shock. 3-prong dryer cords contain two 'hot' wires along with a third wire that contained both the ground and neutral wire. If a current happened to make its way onto the ground wire, it could travel up to the dryer.

Unit 1 - 3-prong

Unit 2 - 3 Prong

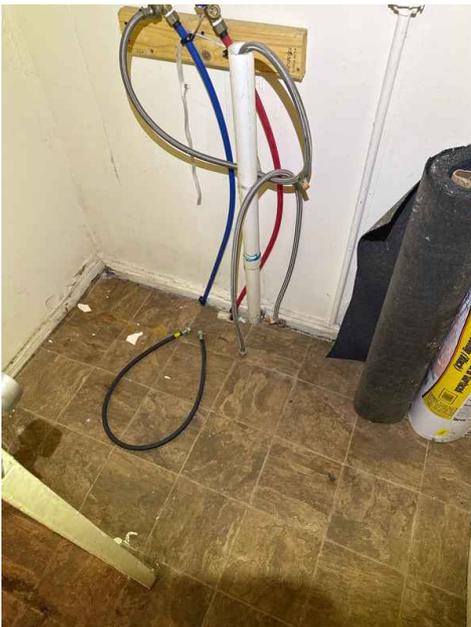
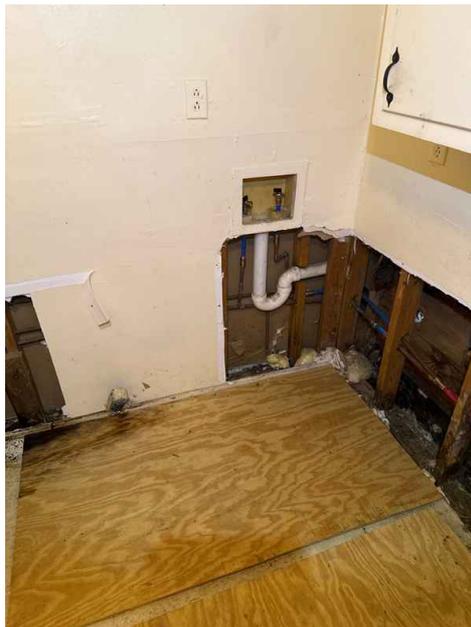
A dryer vent was not present. A dryer vent is recommended to be installed by a qualified contractor that terminates to exterior air.

Contact a qualified professional.

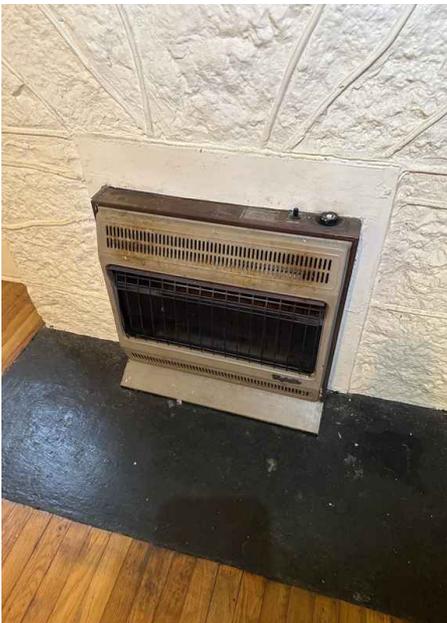
**EXCL** - The pilot light was not lit for the gas wall heater, and the unit was not tested for functionality. I recommend confirming proper operation prior to closing.

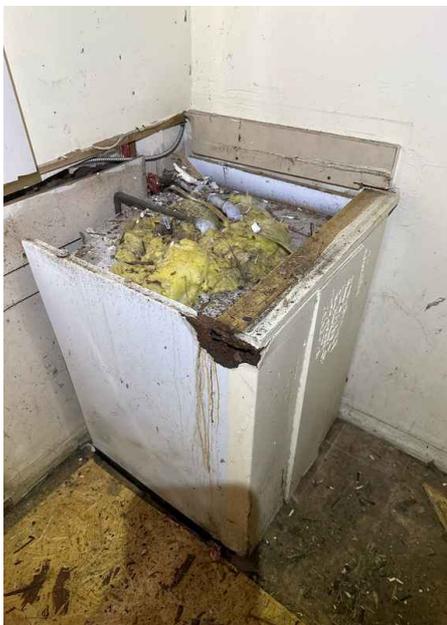
Unit 1

**LMT** - The water heater was located in an enclosure and was not visually accessible. The inspection of the water heater is limited to its functionality to produce heated water only.

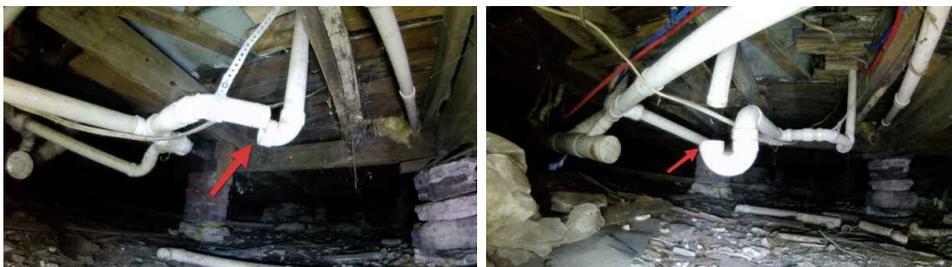
12.6.3 Drain, Waste, and Vent Pipes (DWV)

Significant Defect

Disconnected waste pipe(s) were present. An evaluation of the DWV system is recommended by a licensed plumber with repairs made as needed.

Contact a qualified plumbing contractor.

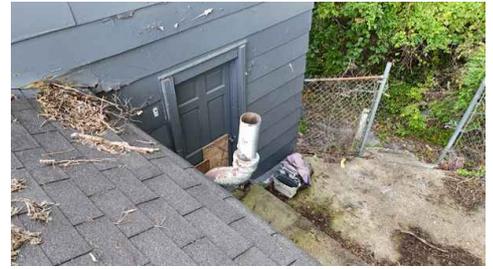
## 12.6.4 Drain, Waste, and Vent Pipes (DWW)

Marginal Defect**CAST IRON/GALVANIZED - AGED DRAIN, WASTE, AND/OR VENTILATION PIPES**

**AGED** - Cast iron and/or galvanized drain, waste, or vent pipes were present. These pipes typically have a 50 - 60 year life and will eventually develop inner corrosion that will affect the draining functionality of the system, and cause failure. These pipes will need to be monitored for performance, with the understanding that major repairs or replacement will be needed at some point in the future due to their age. The remaining life is undeterminable. A sewer camera inspection of the pipes is highly recommended due to their age.

Contact a qualified plumbing contractor.

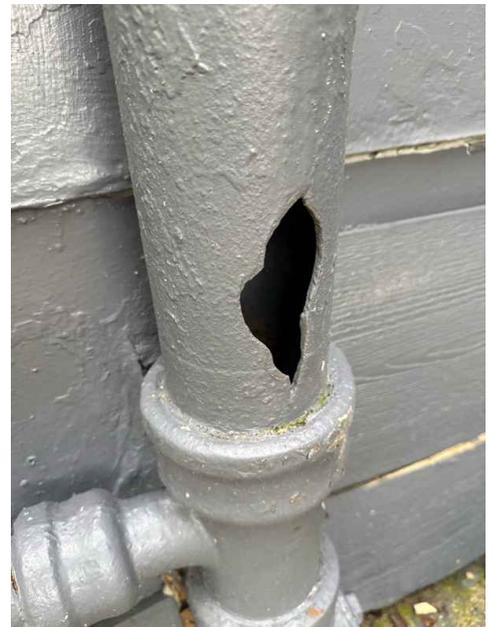
## 12.6.5 Drain, Waste, and Vent Pipes (DWW)

Significant Defect**CAST IRON - CRACKED**

A cast iron pipe was cracked. An evaluation of the pipes with replacement / repairs made as needed is recommended by a licensed plumber.

Contact a qualified plumbing contractor.

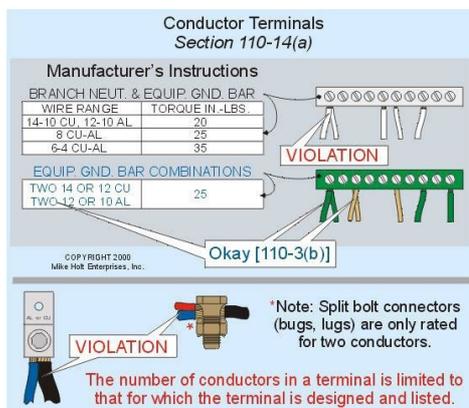
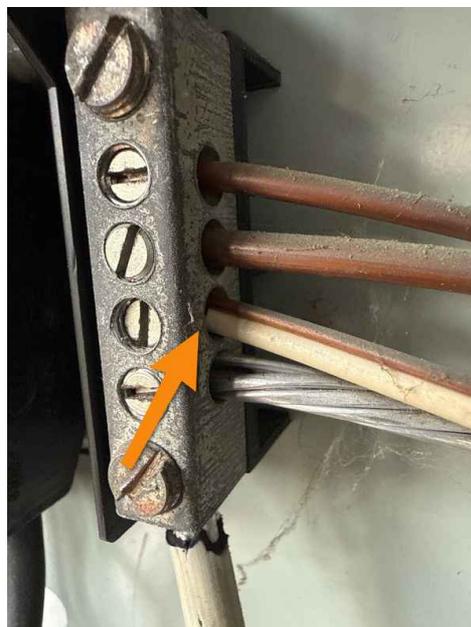
Unit 2

Marginal Defect
**NEUTRAL WHITE WIRES - SHARING SAME LUG (MAIN PANEL)**

Grounded "neutral" conductors were sharing a terminal lug with another neutral and/or ground wire(s) (EGC's) on the terminal bar(s). When a neutral conductor is sharing a terminal lug with another neutral conductor, it can prevent a circuit from safely being isolated for repair. It can also create an overvoltage condition that may damage lighting and appliances during servicing of the panel and circuits.

Mixed neutrals and grounds at a terminal lug can potentially allow current to flow on a ground wire during servicing of a circuit, which can possibly create a shock hazard on metal appliances on one circuit, or an overcurrent situation on another circuit.

All grounded neutral conductors in this panel are recommended to be isolated on a separate terminal lug on the terminal bar by a licensed electrician.

Contact a qualified electrical contractor.

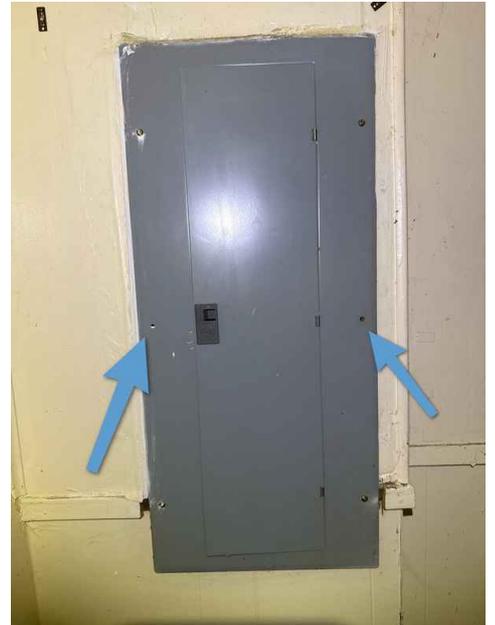
Unit 2

Minor Defect, Maintenance Item, or FYI Item

**COVER - MISSING SCREWS**

Some panel cover screw(s) were missing. All panel cover screw locations are required to be utilized to adequately secure the cover to the panel. Replacement of the screws is recommended to be conducted by a qualified person.

Contact a qualified electrical contractor.

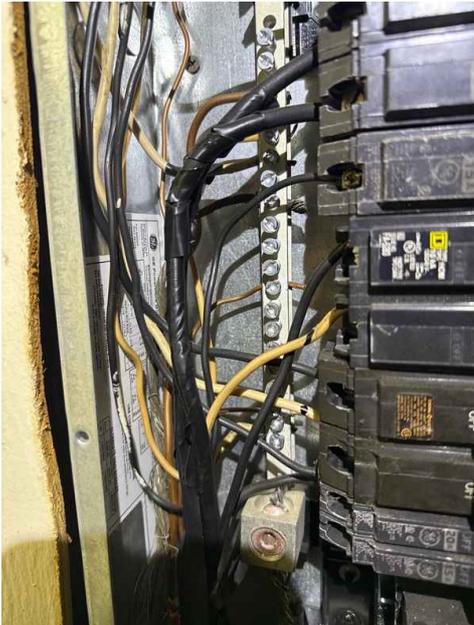
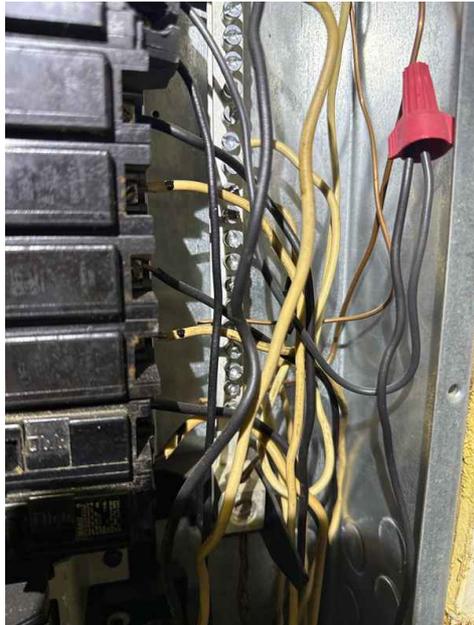
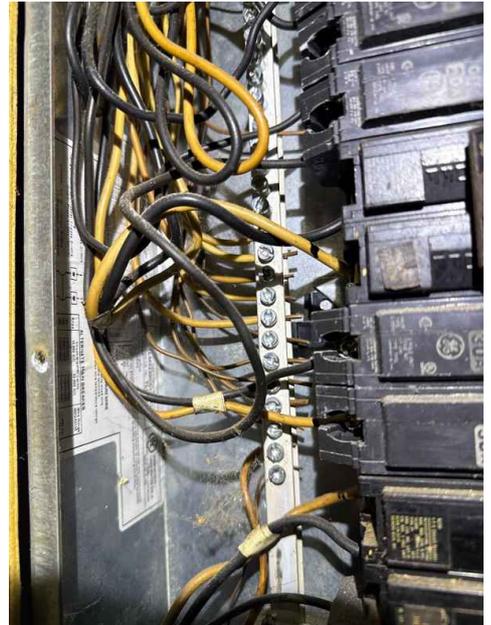
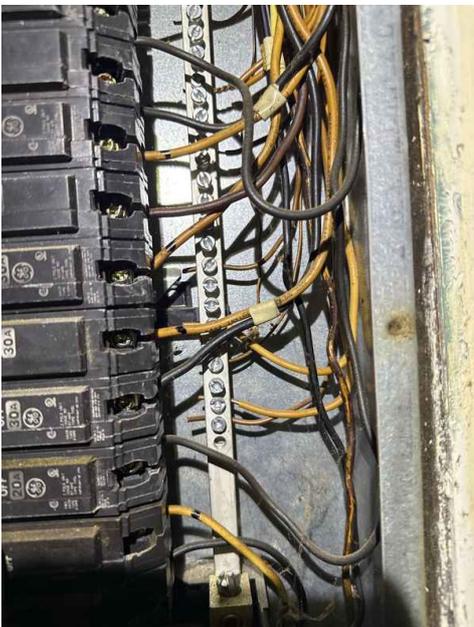
Marginal Defect

**SFTY** - The grounded "neutral" conductors and grounds (EGC'S) were not isolated in the distribution panel(s). The grounds should be on a separate terminal bar that is bonded to the enclosure, and the neutrals should be on a second "floating" terminal bar that is not in contact with the panel. The current configuration can allow current to run on the ground wires if a fault was to occur, possibly creating a shock hazard on appliances. Repairs are recommended to be conducted as needed by a licensed electrician for safety.

Contact a qualified electrical contractor.

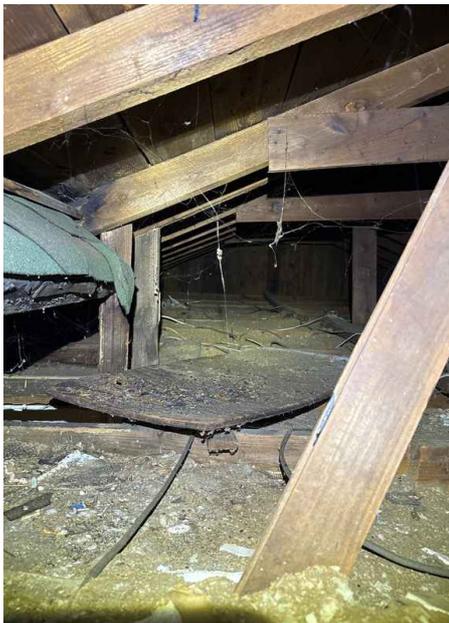
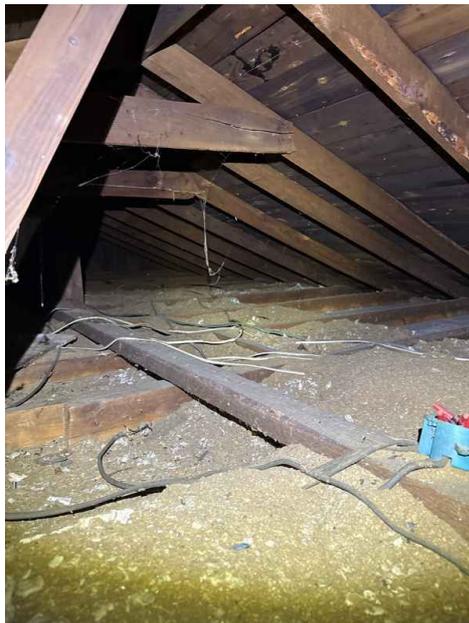
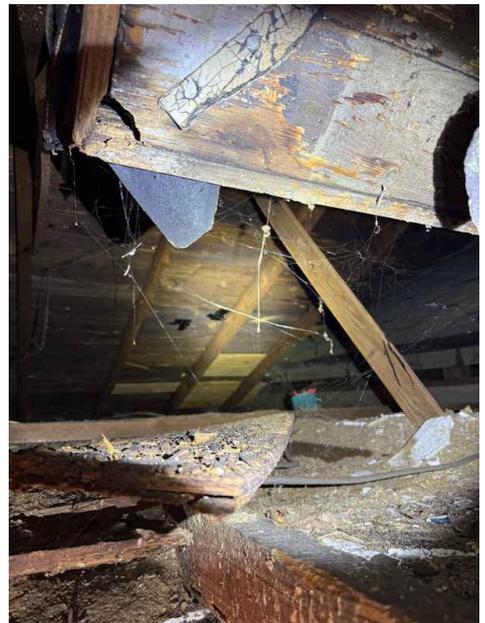
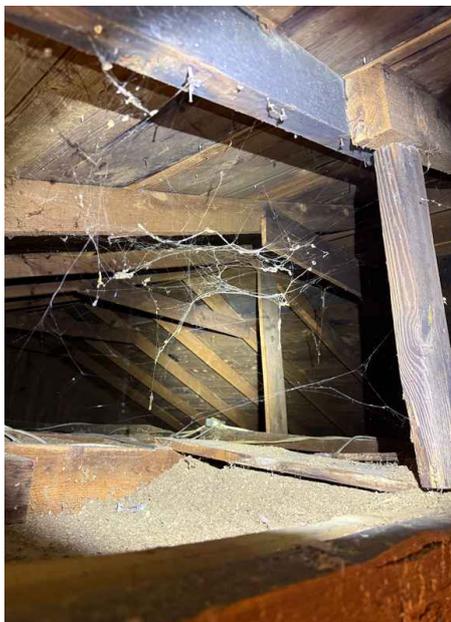
**General Info/Limitations: Attic View(s)**

A few attic photos

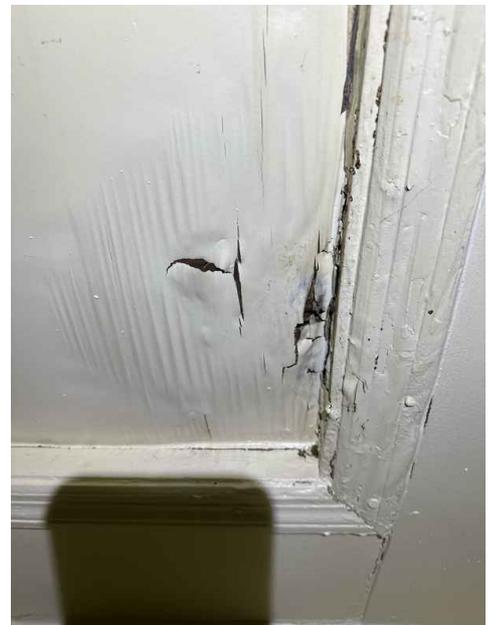
**PANEL - WATER DAMAGED**

The attic access panel area was water damaged. Repairs are recommended.

Contact a qualified professional.

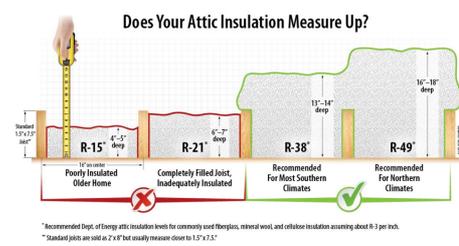
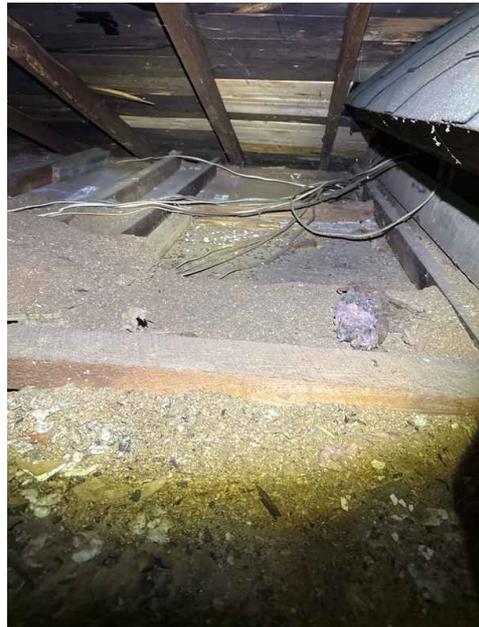
### INSULATION - TYPICAL AMOUNT & AGED (MORE RECOMMENDED)

The insulation level was typical for when the home was built, but current energy star standards recommend approximately 14 inches of insulation to achieve an R-38 rating. The installation of new insulation to replace / add to the original as an upgrade is recommended for comfort and energy efficiency by an insulation contractor.

Contact a qualified insulation contractor.

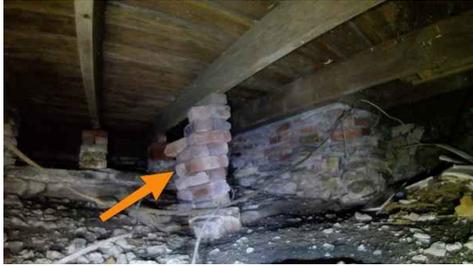
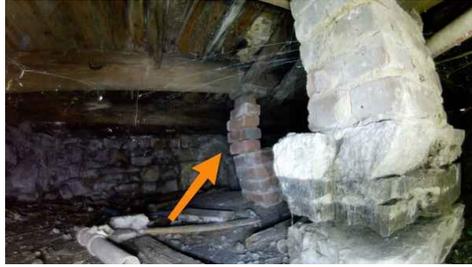
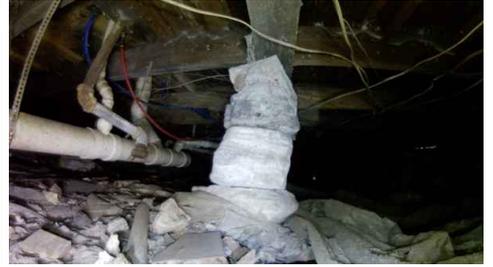
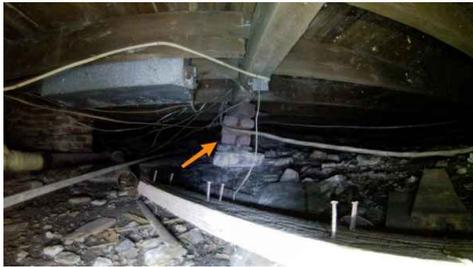
**PIER(S) - OUT OF PLUMB**

Contact a foundation contractor.

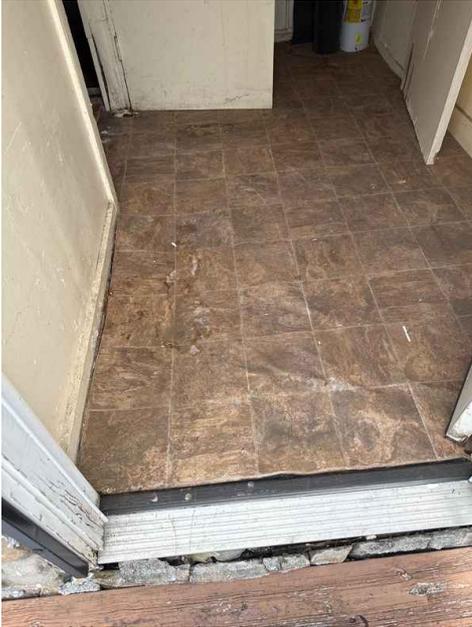
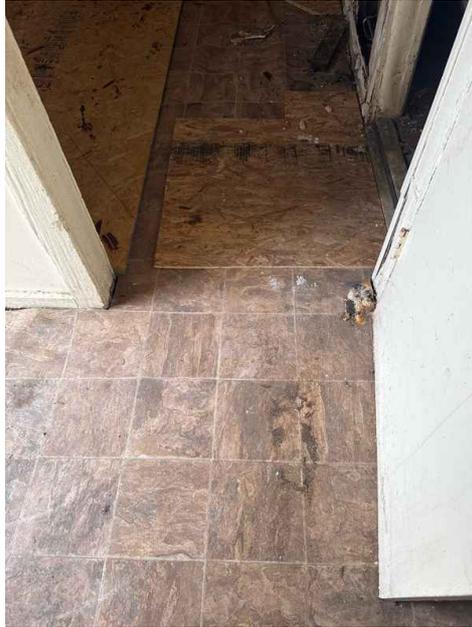
Unit 1 Foyer

**FLOOR(S) - WATER DAMAGE PRESENT**

Water damage was present to the flooring at the referenced area(s). An evaluation of the subfloor, with repairs made as needed is recommended to be performed by a flooring contractor or other qualified person.

Contact a qualified flooring contractor

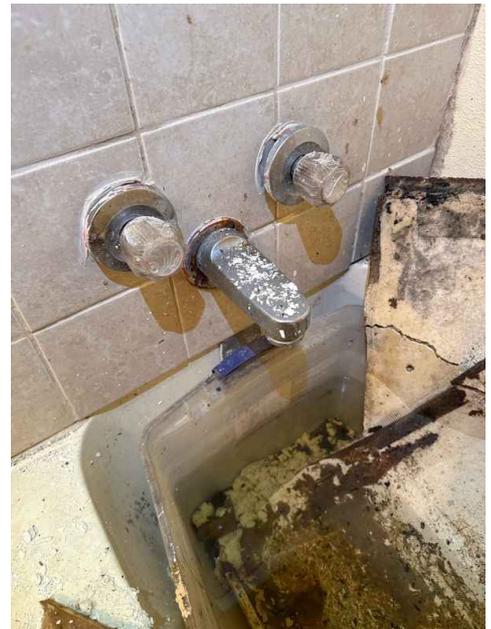
Unit 2

**FAUCET VALVE - DRIP LEAK WHILE OFF**

A drip leak was present from the referenced faucet while the valve was in the "off" position. Repairs are recommended to be performed as needed by a licensed plumber to correct the leak.

Contact a qualified plumbing contractor.

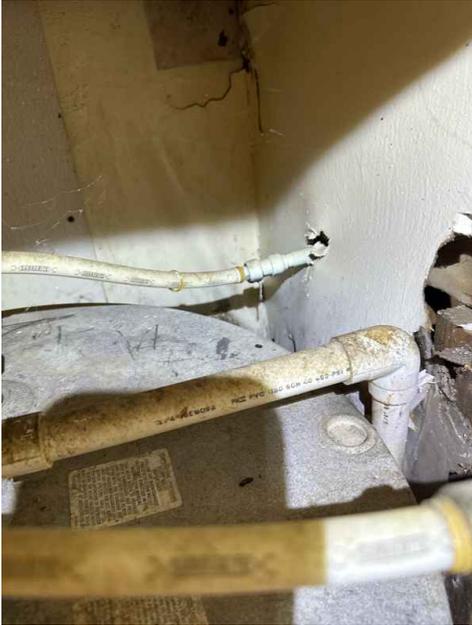
Unit 2 Water Heater Area

**WATER PIPE - LEAK**

A leak was present from the referenced water pipe(s). Repairs are recommended as needed by a licensed plumber.

Contact a qualified professional.

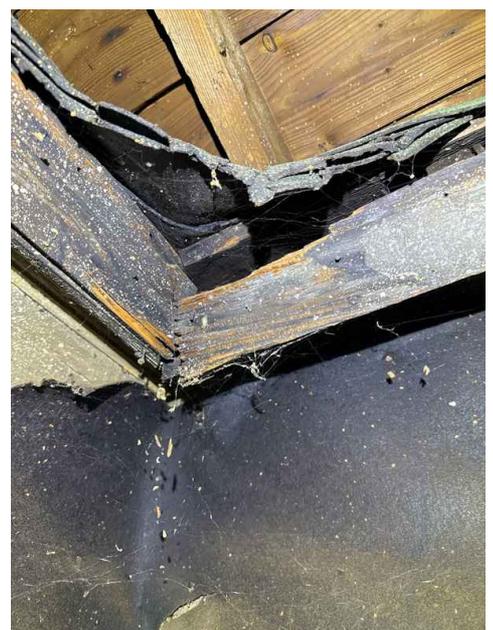
**SUBFLOOR / FLOOR STRUCTURE / SUPPORT - MOISTURE STAINING / DAMAGE PRESENT**

There were moisture stains with some areas having varying levels of damage present on the subfloor and/or floor structure. Although the area(s) were not actively/visibly leaking at the time of inspection, moisture stains should be viewed as active leaks until they prove themselves otherwise, as I can only report on the conditions as they existed at the time of inspection and can not confirm if this is from a past or present leak. A full evaluation of the floor structure is recommended to be performed by a qualified contractor with repairs made to any damage present, and to rectify any leaks that may be found.

Contact a qualified professional.

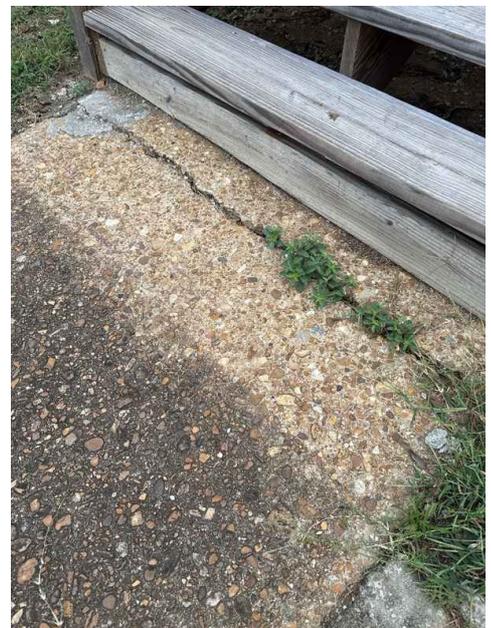
**ASPHALT - CRACKING**
